# KNOXVILLE SOUTH WATERFRONT, TENNESSEE

## PUBLIC IMPROVEMENTS

### *Existing Natural Resources and Ecological Evaluation Report*

**SOUTH KNOXVILLE WATERFRONT**  
**EXISTING NATURAL RESOURCES**  
**AND**  
**ECOLOGICAL EVALUATION REPORT**  
**DRAFT**

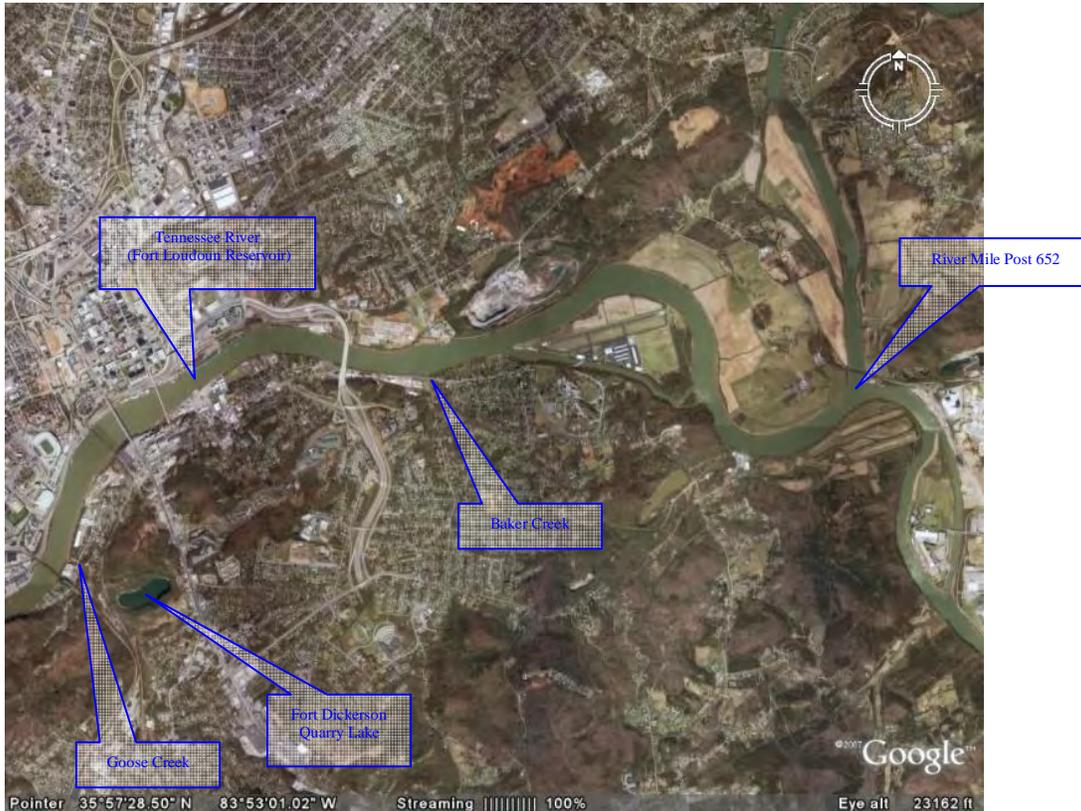
Figure 3. Surface waters located within the South Knoxville Waterfront area. Source: GoogleEarth 2008.

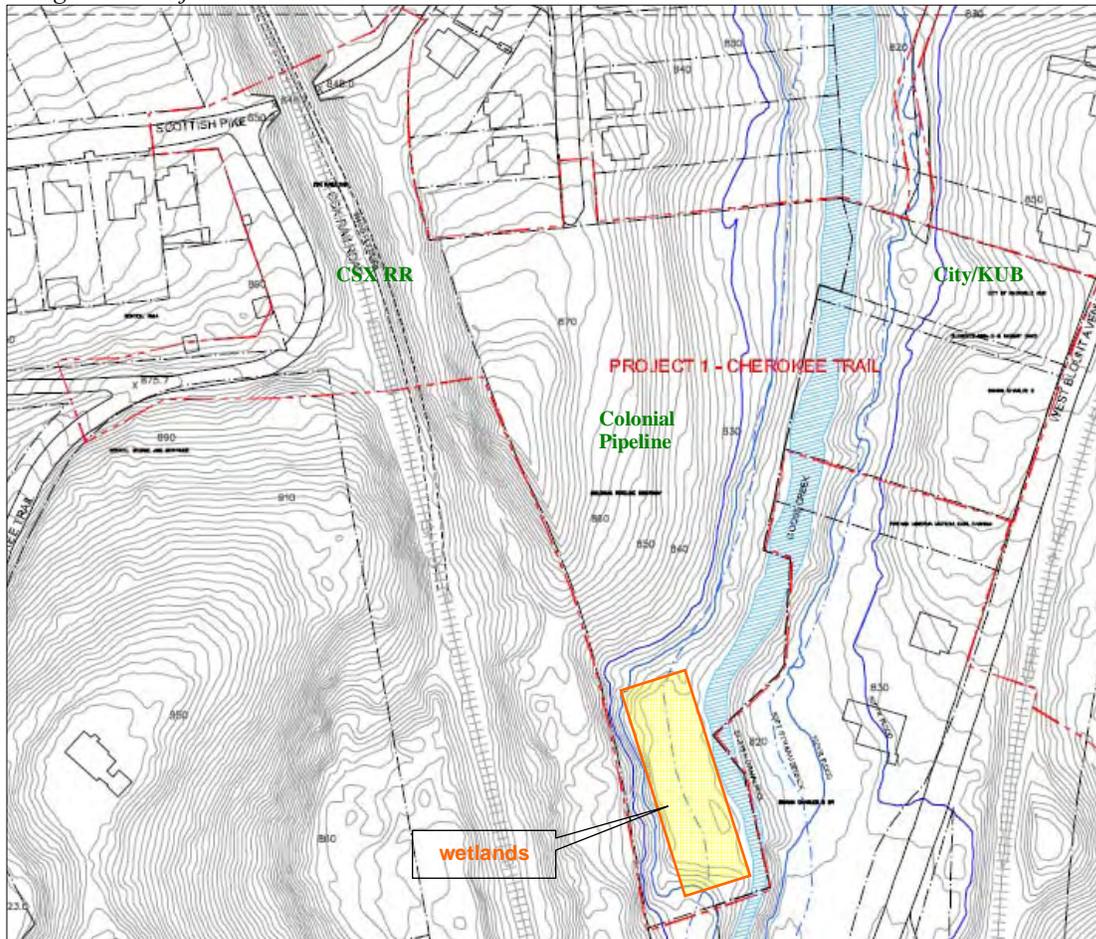
Figure 4. Project 1 area – Cherokee Trail Connector.

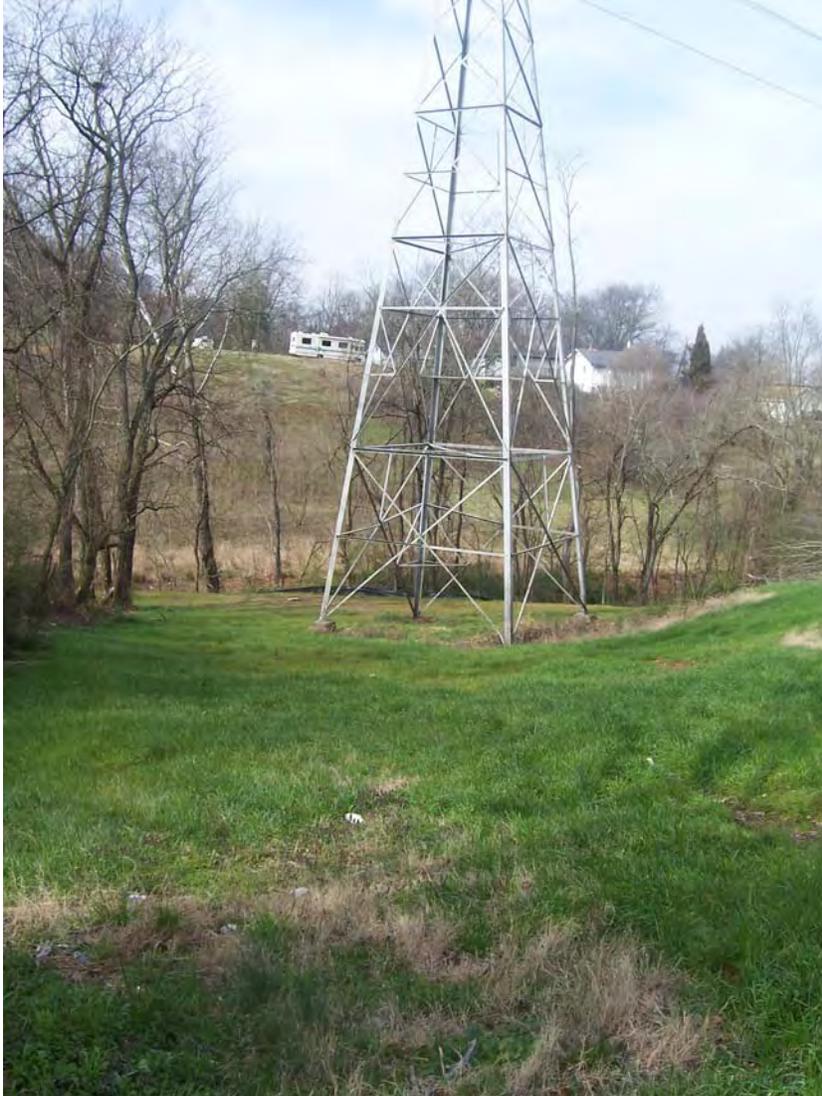
Photograph 1-30. View to south. Wetland area in southern portion of Colonial Pipeline property along the west bank of Goose Creek.

A small wetland area was observed in the southern most end of the site. The area, located within the 100-year floodplain, was evidenced by the presence of facultative plants such as horse-tail (*Equisitum, spp.*). The total area of the wetlands is estimated at 0.125 acres.

- Construction in, and disturbance of, the noted wetland area in the southern portion of the site should be avoided if at all possible. If deemed necessary to disturb or impact this wetland area, an ARAP and consultation with TDEC will be required and mitigation measures will need to be implemented.

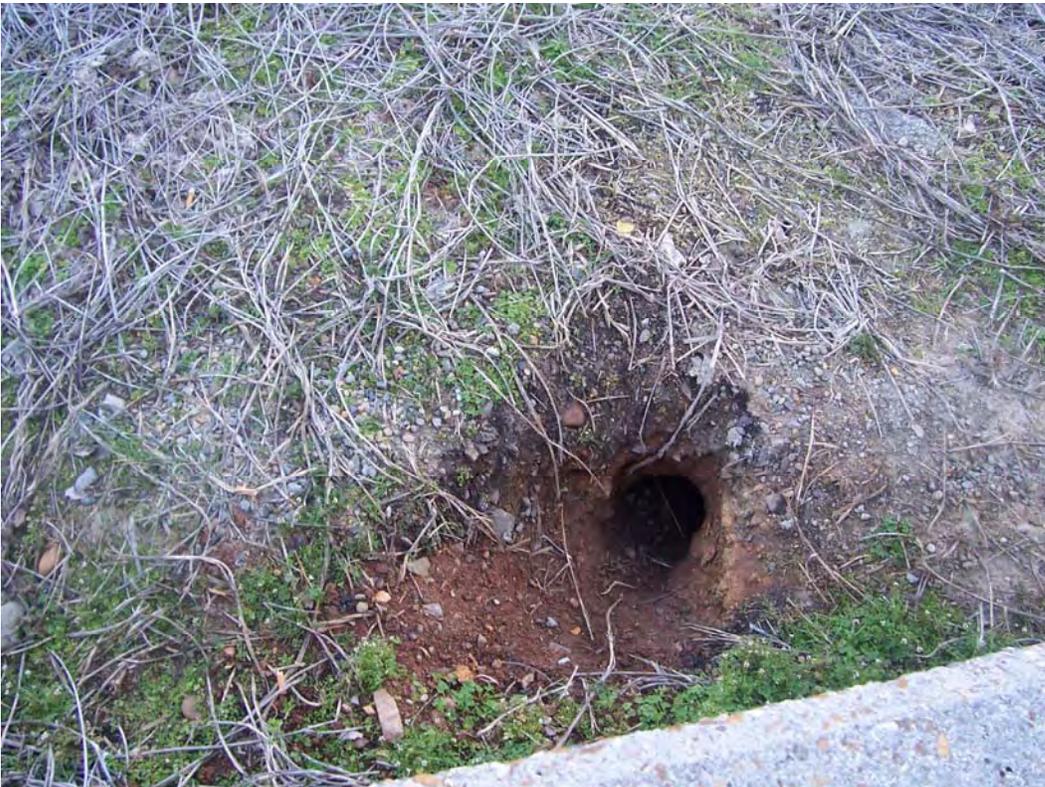
Photograph 6-11. View to northwest of bluff area near parking garage. Evidence of groundhog (*Marmota monax*) activity. Presence of invasive vegetative species kudzu.

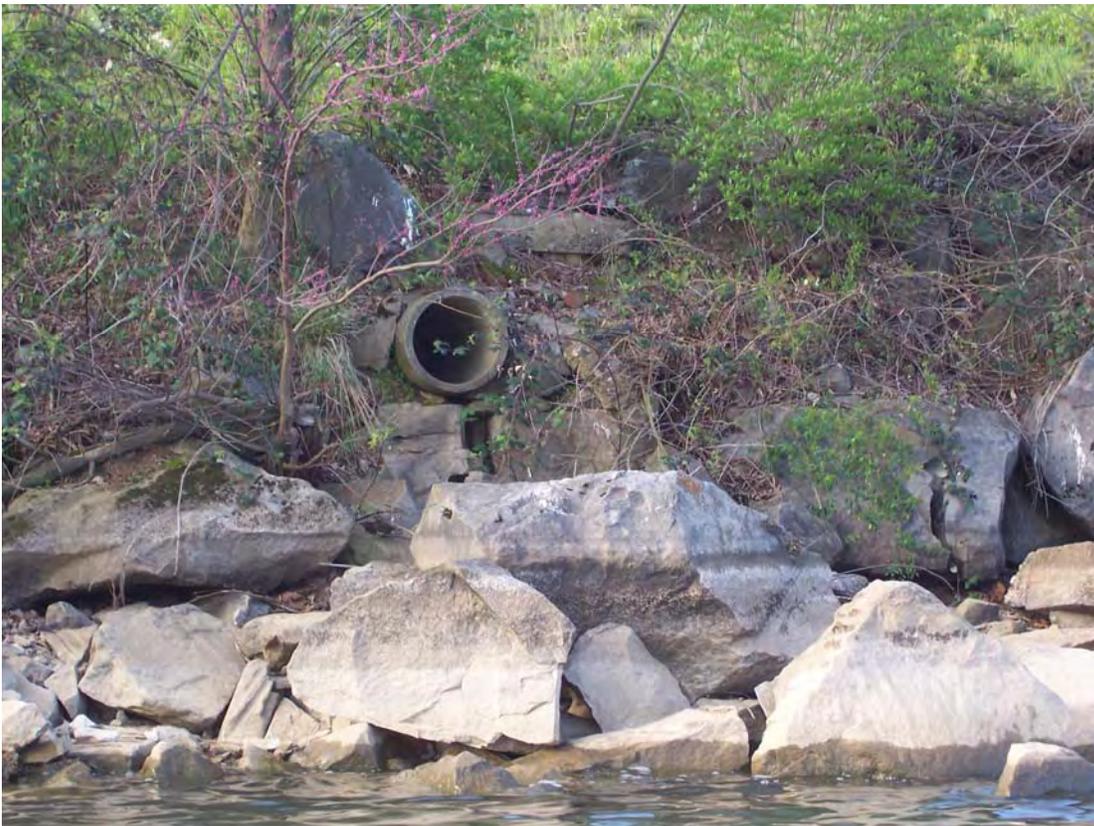
Photograph #BT-4. Outfall for Industrial Stormwater NPDES permit TN0022535 from former TransMontaigne Fuel Tank Farm property on Island Home Avenue. Outfall located in western end of Project 11 in rip rap area.

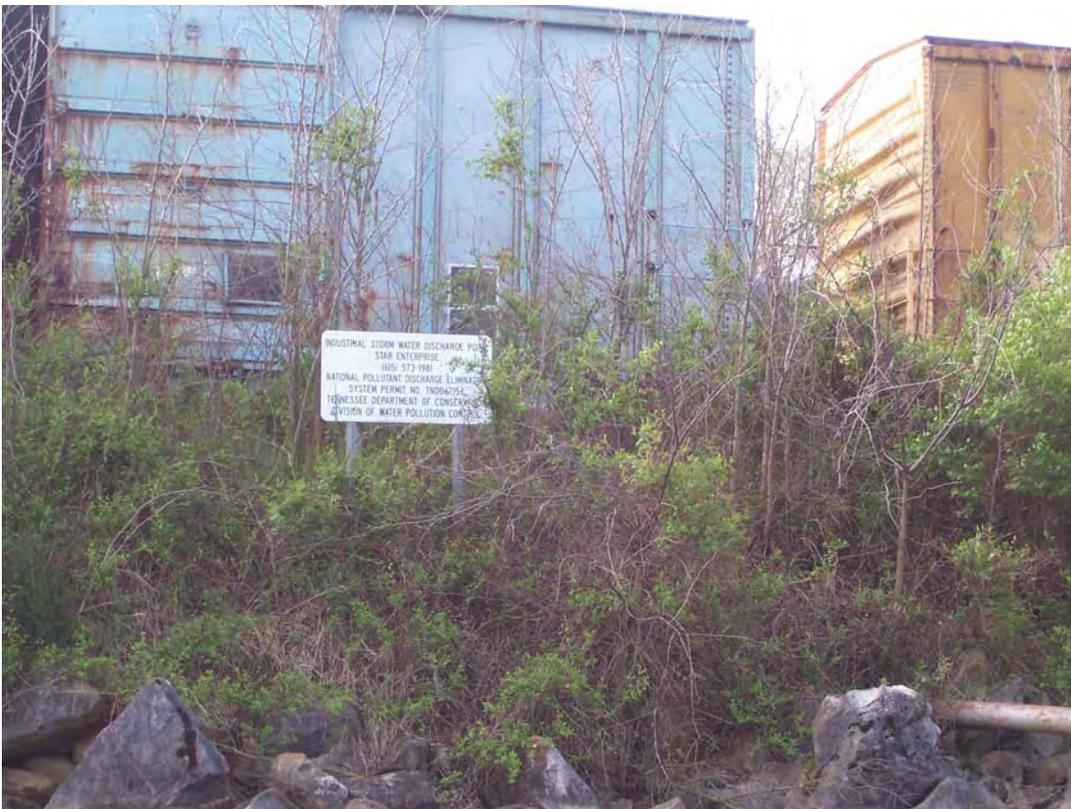
Photograph #BT-22. View to south of outfall for Industrial Stormwater NPDES permit TN0067156 for the former Star Enterprises fueling area on the Project 9 site.

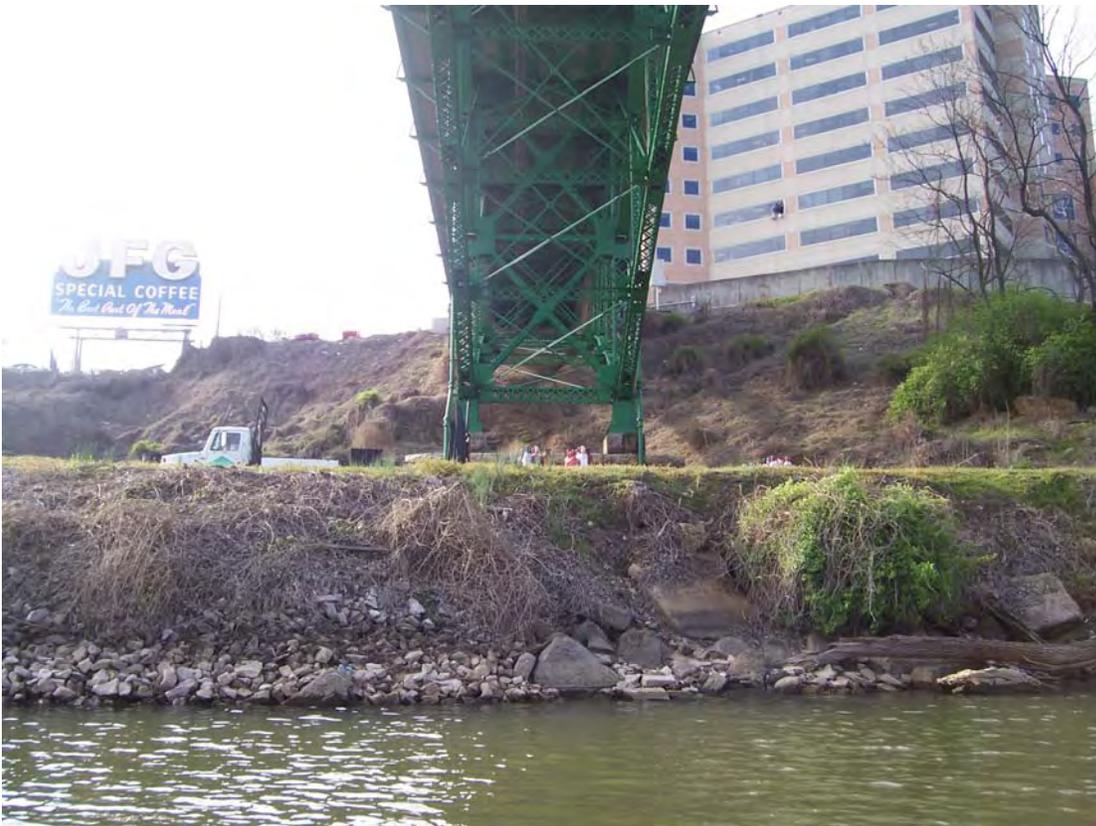
Photograph #BT-27. View to south of Project 7 area and Gay Street Bridge. Stormwater outfall from Holston Gas property.

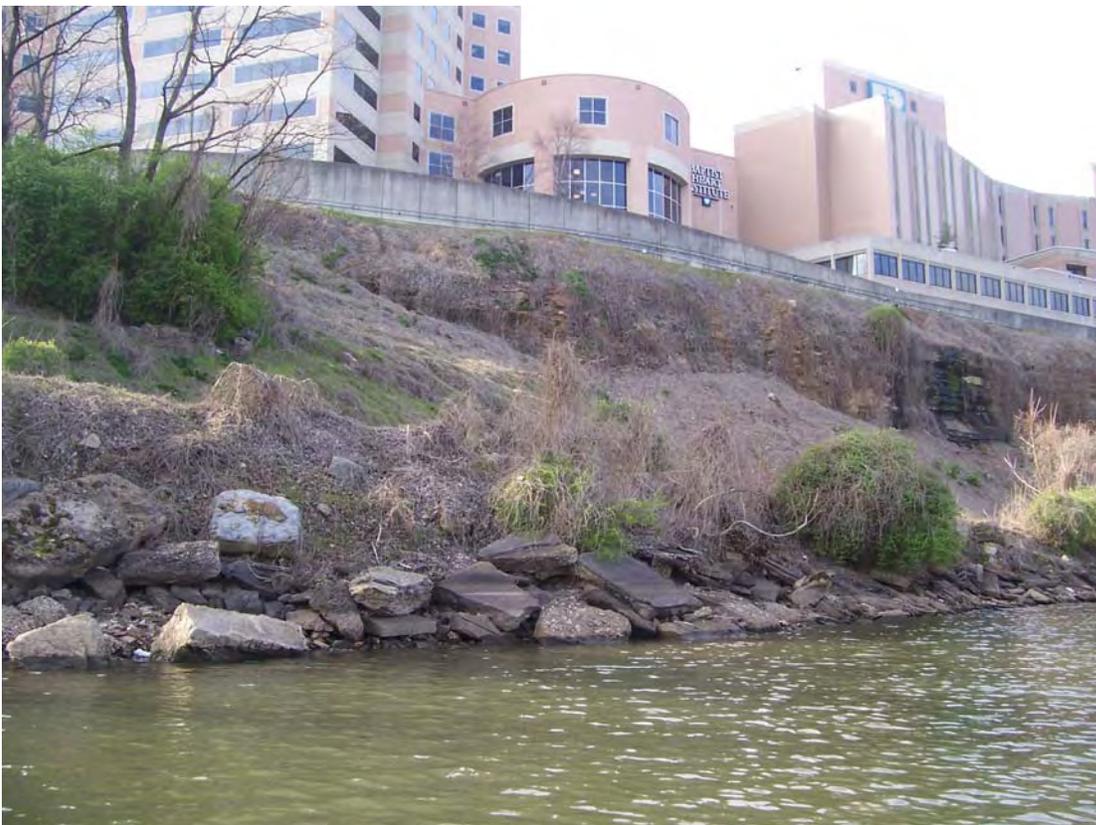
Photograph #BT-29. View to south of Project 6 area. Kudzu (*Pueraria montana*), an invasive species, covers the limestone bluff in front of Baptist Hospital. A large shoal area is located in this project area between the Gay Street and Henley Street Bridges.

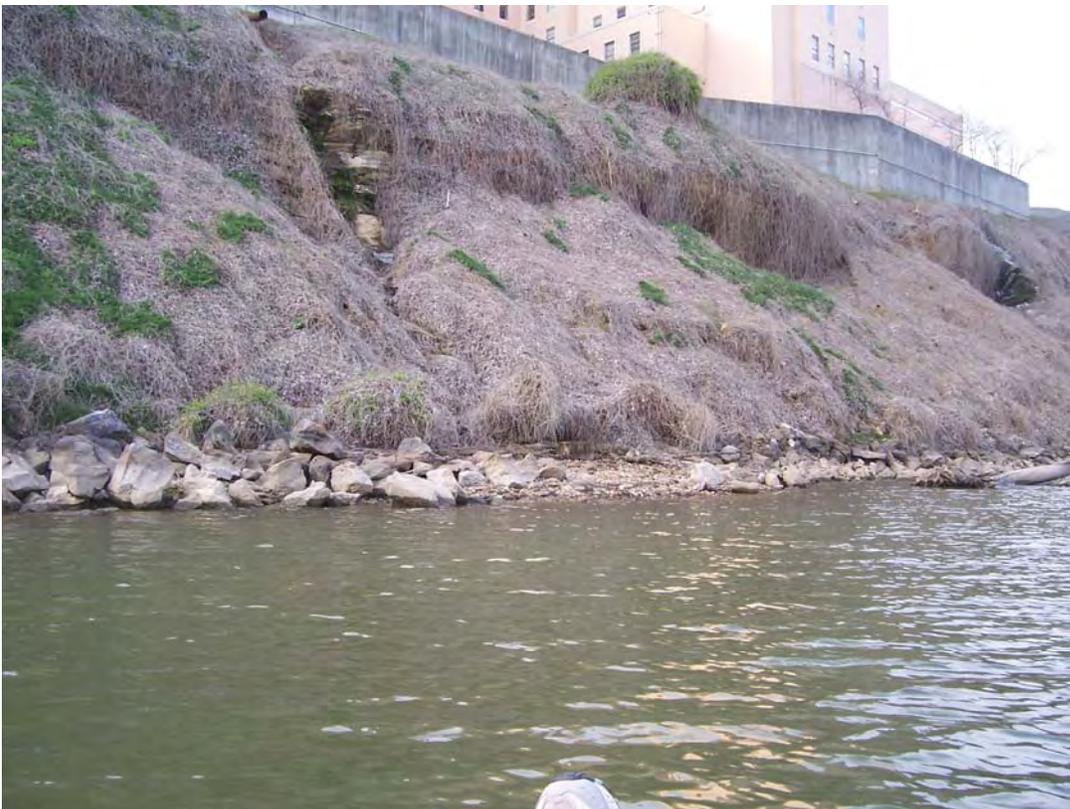
Photograph #BT-33. View to south of extensive kudzu coverage of limestone bluff in Project 6 area. Stormwater outfall from Baptist Hospital located in center of photograph.
