THE CITY OF KNOXVILLE TENNESSEE

NPDES Permit Annual Report

National Pollutant Discharge Elimination System
Stormwater Discharge Permit TNS068055
July 1, 2006 - June 30, 2007

**RE: City of Knoxville, NPDES MS4 Permit # TNS068055
2006 – 2007 Annual Report**

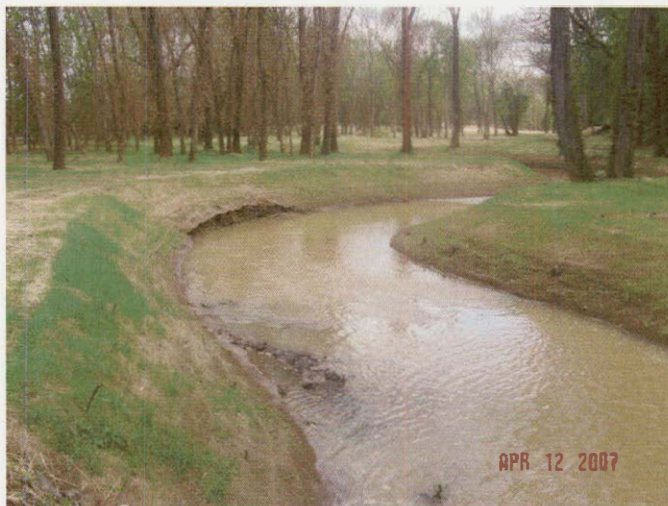
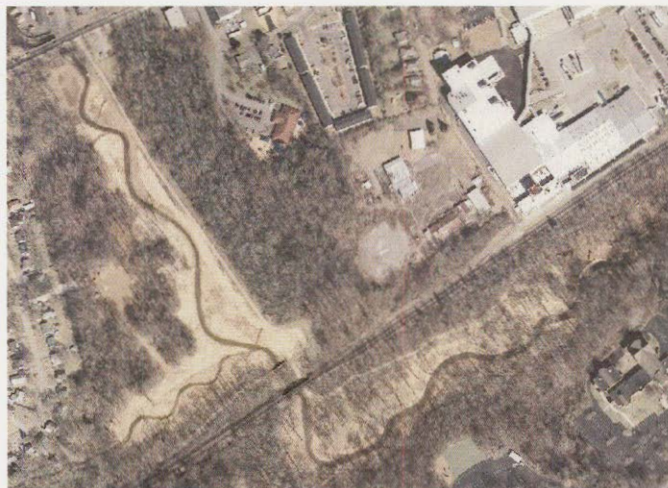
Buck Engineering substantially completed the design plans in year two. Construction began in the fall of 2006. The initial focus was to meander the channelized section of stream downstream of Sutherland Avenue (see photo). The section of creek was apparently straightened in the past, which has caused slow widening of the channel and a steady loss of trees. Soil was removed from the floodplain to provide some additional storage and reduce erosive flows. The areas around the creek were stripped of all invasive species of vegetation and replanted with native trees and shrubs. Volunteers from the community and property owners will be involved with maintenance and monitoring in the future. More information on the project and plans is available at www.tsmp.us.

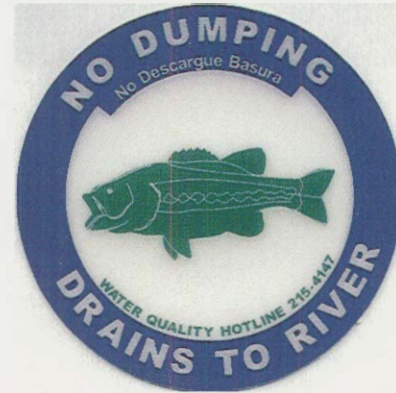
The message “DUMP NO WASTE, DRAINS TO STREAM” was stenciled on over ten thousand storm drains earlier in the permit term. In the last few years, the City replaced the stenciling program with DAS curb markers. These brightly colored plastic disks are affixed to the curb irons and carry the message “Dump no Wastes, Drains to Stream”. Although the curb markers are a temporary retrofit for the existing storm drains, they are more economical and environmentally friendly since they do not wear off as quickly as the painted stencils. When the disks were first introduced, volunteers and City staff placed several thousands of markers on storm drains in the city. Currently, several hundred of the informational disks are purchased and distributed to volunteers each year to attach to curb irons. During year one the disks were revised to include the Water Quality Hotline phone number and some Spanish text.

In the City’s new permit application, a permanent version of this educational program was proposed. The City has already adopted a new development standard for all new curb irons and solid stormwater manhole covers. The new standard requires the iron to be cast with the educational message included on top of all new curb irons and solid manhole lids. In an effort to make the curb irons more eye-catching, several foundries have cast into the iron a graphic of a fish in addition to the environmental message. The foundries offer these designs to the surrounding communities to simplify their stock requirements. This program should offer long-term educational benefits as citizens become familiar with the message and it’s meaning.

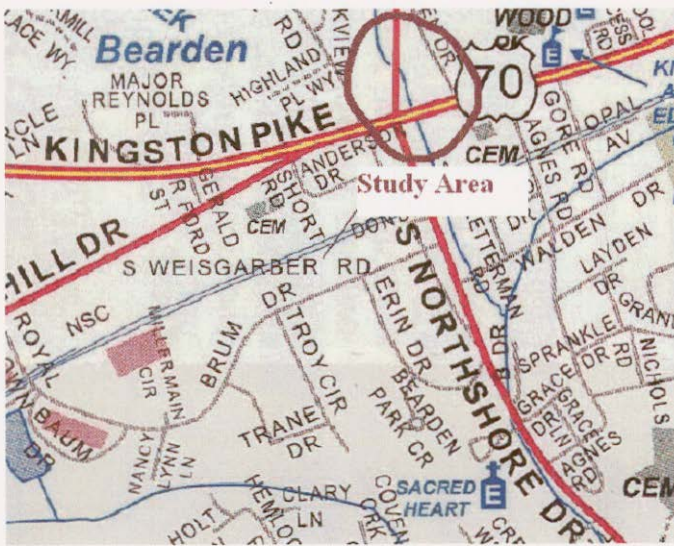
Figure 1: down stream survey site at Kingston Pike and Northshore Dr.

FLLA assessed two sites along Fourth Creek for this IBI. The down stream site was located near the intersection of Kingston Pike and Northshore Dr. (see Figure 1). This survey site was conducted at approximately 1.75 miles up stream from the confluence with Fort Loudoun Lake. The upstream site was located near 1122 Old Weisgarber Rd. (see Figure 2). This survey was conducted at approximately 4 miles up stream from the confluence with Fort Loudoun Lake. The site near Kingston Pike and Northshore Dr. has an approximate drainage area of 6 square miles and the site on Old Weisgarber has an approximate drainage area of 5 square miles.

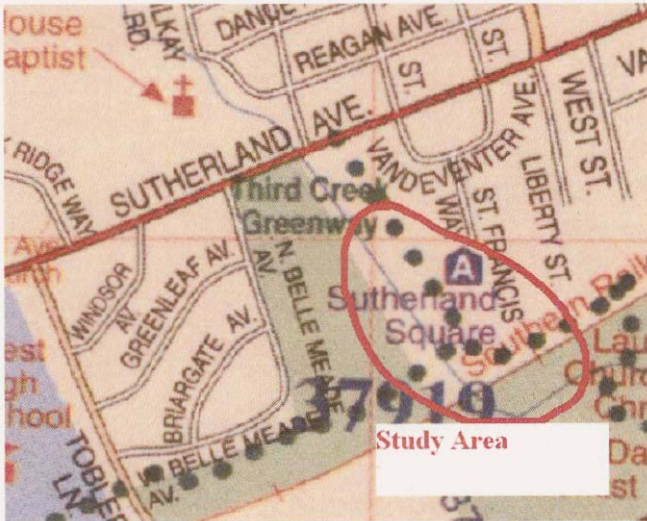
Figure 1: down stream survey site at Cox St and Sutherland.

FLLA assessed two sites along Third Creek for this IBI. The down stream site was located near the intersection of Cox St. and Sutherland Ave. at the Tennessee Stream Mitigation Project (see Figure 1). This survey site was conducted at approximately 3 miles up stream from the confluence with Fort Loudoun Lake. The upstream site was located at the intersection of Middlebrook Pike and Lonas Rd. (see Figure 2). This survey was conducted at approximately 4.75 miles up stream from the confluence with Fort Loudoun Lake. The site near Cox St. and Sutherland Ave. has an approximate drainage area of 10 square miles and the site near Middlebrook Pike and Lonas Rd. has an approximate drainage area of 3 square miles.

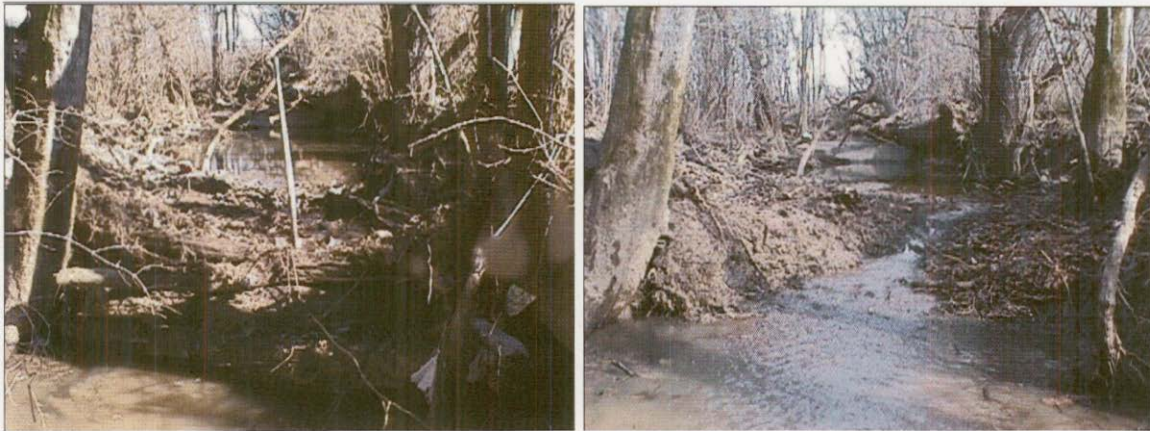
N 35°54.234'
W 084°08.051'

Staff members Mark Campen and Jake Hudson removed this weir January 30, 2007. The weir was made up of several logs and consolidated debris that extended from bank to bank. Trash was accumulating upstream in the pool trapped by the weir. Using a chain saw, an axe and a mattock, the logs were cut into manageable sized pieces and hauled above the flood stage shelf. The accumulated trash was bagged and removed. The sediment bar that had formed upstream of the weir, was dug out and a new channel created to restore the natural flow.

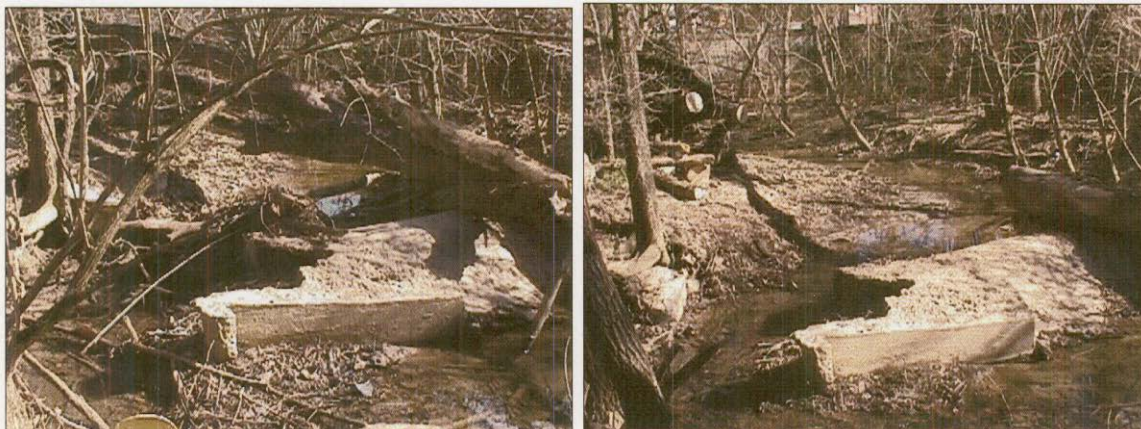
Turkey Creek Weir - 02

Staff members Mark Campen and Jake Hudson removed this weir January 30, 2007. The weir was made up of several logs and consolidated debris resting on and upstream of a concrete structure and extending from bank to bank. The largest log was two and one-half feet in diameter and had trapped several other logs. Trash had accumulated upstream in the pool trapped by the weir.

Using a chain saw, an axe and a mattock, the logs were cut into manageable sized pieces and hauled above the flood stage shelf. The accumulated trash was bagged and removed. Removal of these logs allowed the flow to resume around the concrete structure.

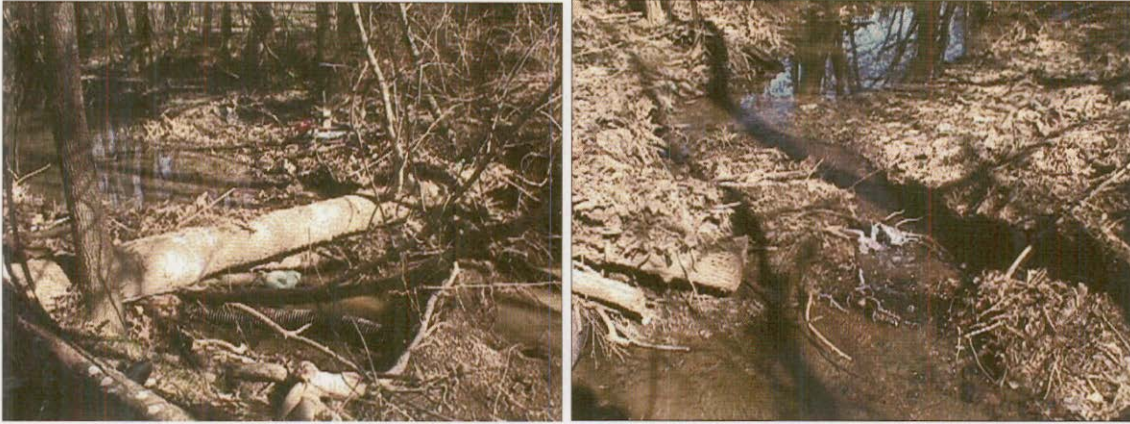
N 35°54.234'
W 084°08.028'

Staff members Mark Campen and Jake Hudson removed this weir January 30, 2007. The weir was made up of several logs and consolidated debris including a portable swimming pool, several sections of corrugated PVC pipe and two tires, and it extended from bank to bank. The largest log was two feet in diameter and was on top of several other logs and the majority of the debris. Sediment and trash had accumulated upstream in the pool trapped by the weir.

Using a chain saw, an axe, a mattock and a come along, the logs were cut into manageable sized pieces and hauled above the flood stage shelf. The accumulated trash was bagged and removed.

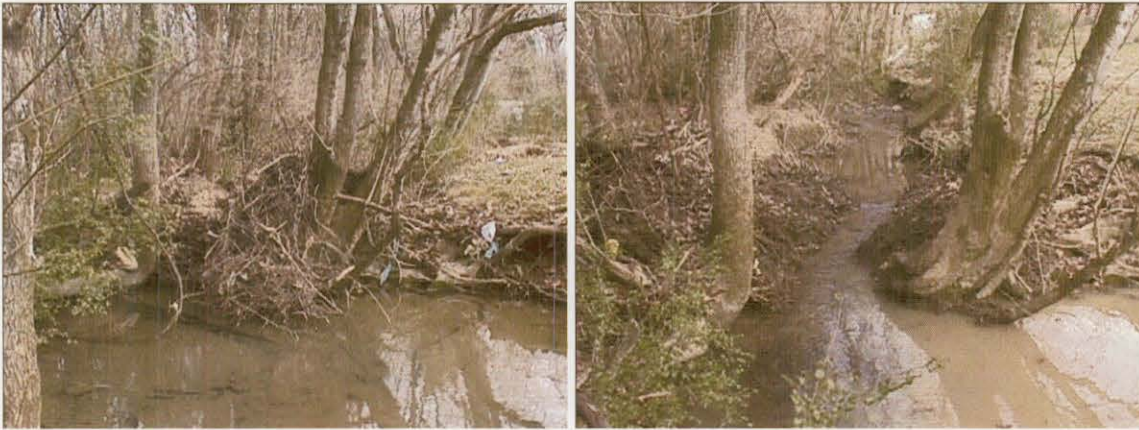
N 35°54.224'
W 084°08.053'

Staff members Mark Campen and Jake Hudson removed this weir March 8, 2007. The weir was made up of consolidated debris and trash trapped between two trees growing in the channel. Sediment and trash had accumulated upstream in the pool trapped by the weir.

Using a mattock, rake and shovel, the debris was removed and hauled above the flood stage shelf. The accumulated trash was bagged and removed.

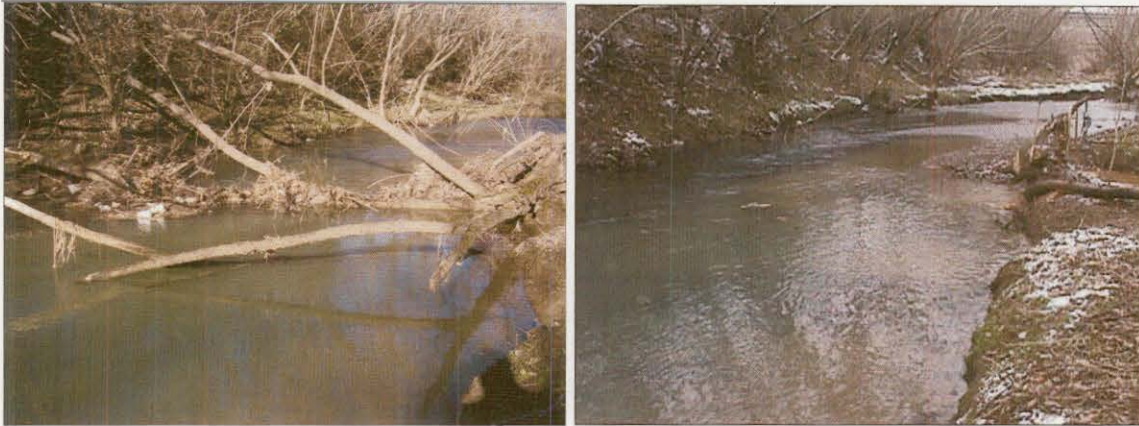
N 36°00.910'
W 083°55.324'

Staff members Mark Campen and Jake Hudson removed this weir January 16, 2007. The weir was made up of a 25' long willow tree with 4 major branches that stretched from bank to bank, and assorted sedimentation, trash, and woody debris. Trash was accumulating upstream in the pool trapped by the main trunk.

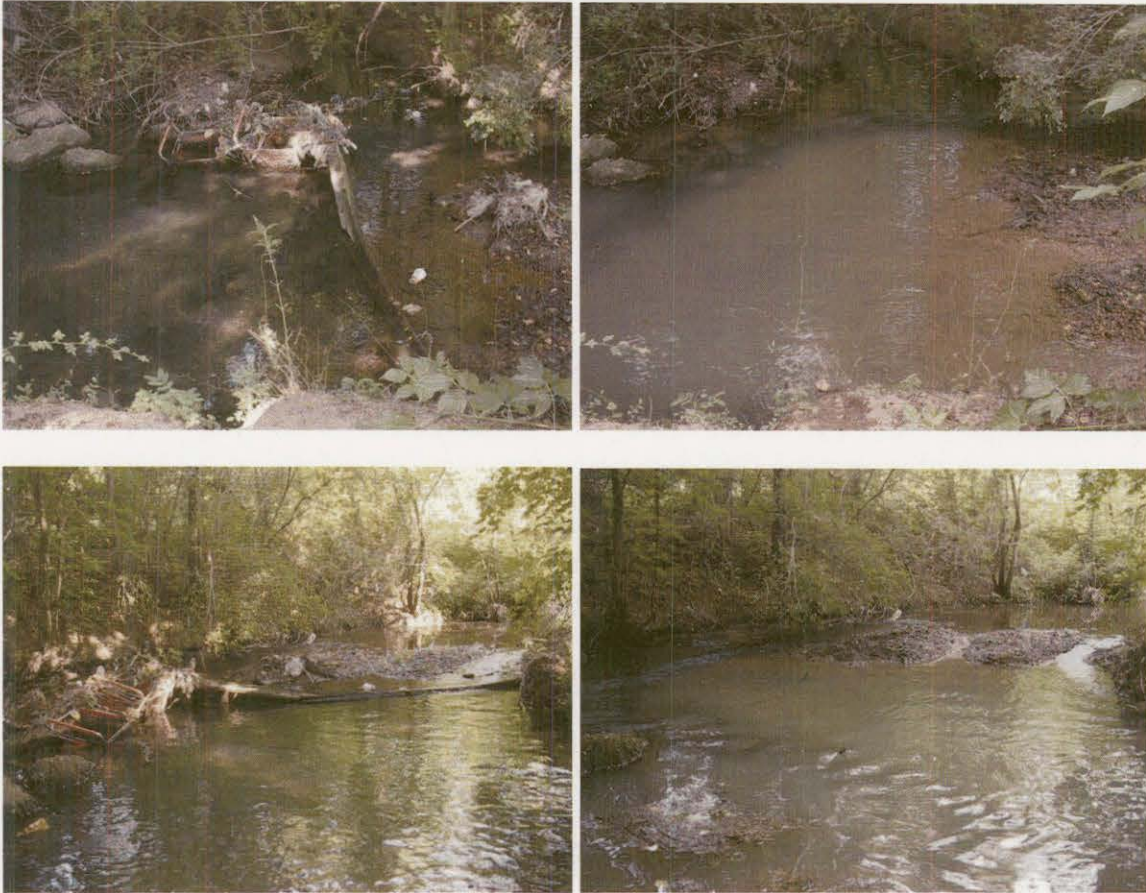
N 36°01.895'
W 083°55.974'

This weir was removed August 13, 2007 by staff members Jake Hudson and Scott Wilson. The weir was made up of a 2' wide wooden form that stretched from bank to bank, two shopping carts that were partially buried by sedimentation, trash, and woody debris. Deep pooling had formed on the downstream side of the blockage and the flow had been diverted to the west bank.

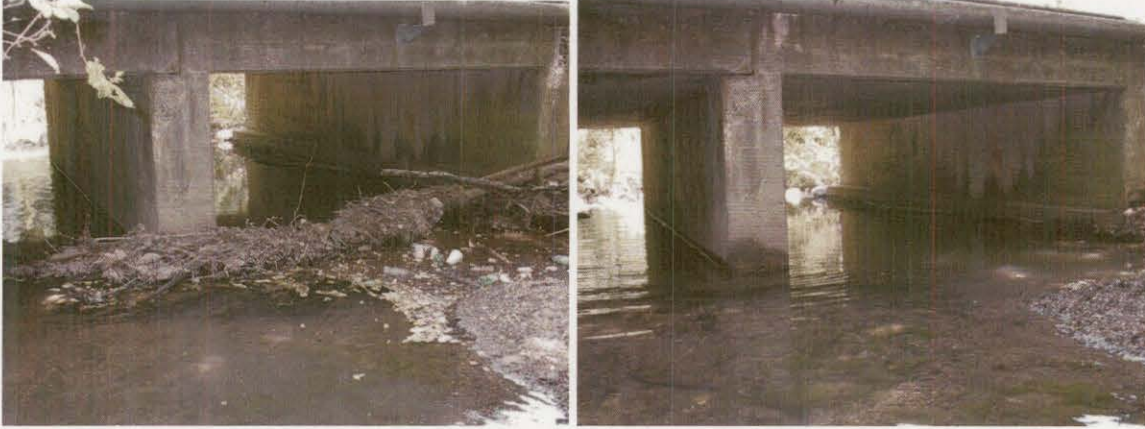
N 35°56.719'
W 083°00.927

This weir was removed by staff member Scott Wilson on May 30th 2007. The weir consisted of several large logs intertwined with smaller woody debris and trash. Approximately 70% of the creek was blocked. The flow was being diverted to the north bank and a deep pool had formed on the south bank. The blockage was removed using a mattock, rake, and handsaw. One bag of trash was collected and removed.

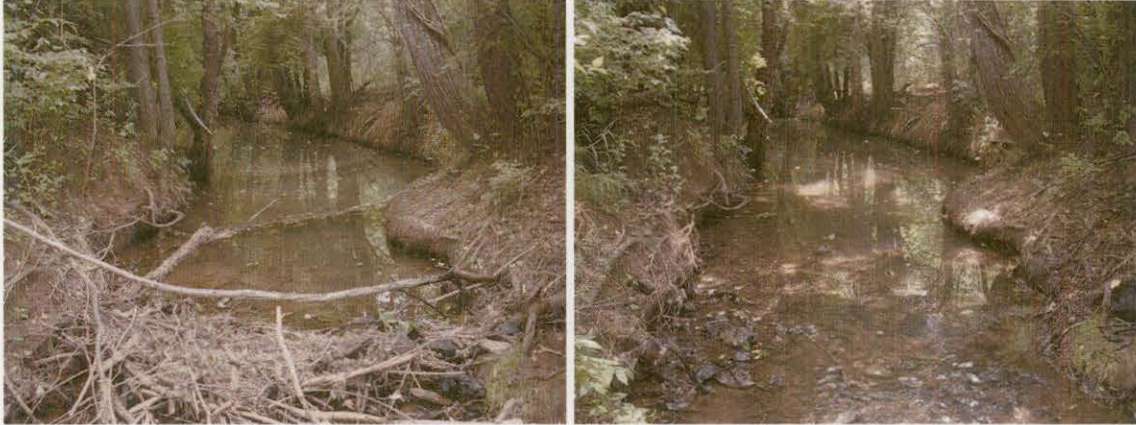
N 35°57.072'
W 083°53.701'

This weir appeared to have been caused by beavers and stretched from bank to bank. This resulted in 100% blockage and deep pooling upstream of the dam.

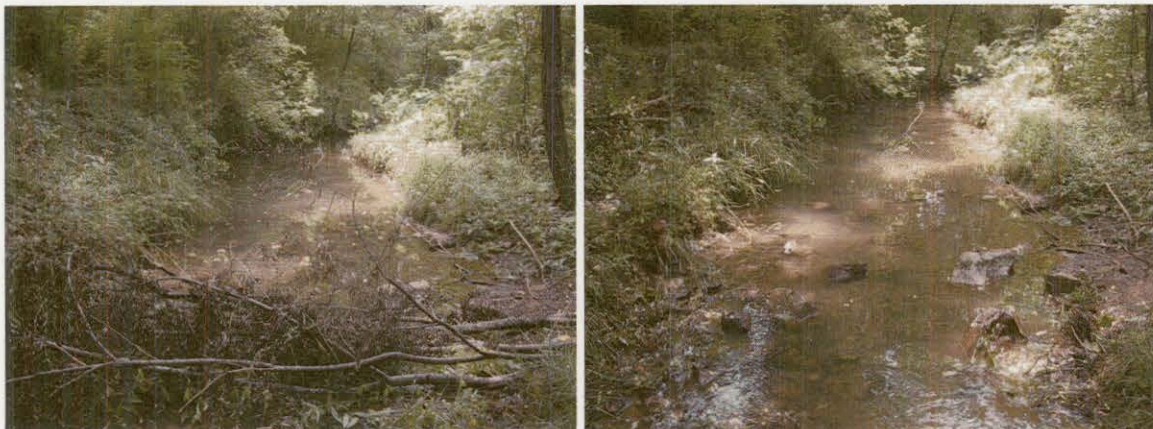
N 35°57.114'
W 083°53.643'

This weir, although smaller than the previous still stretched from bank to bank. The weir was newer and less settled than weir #1. Pooling had started upstream of the dam, but had not gotten as deep as the previous.

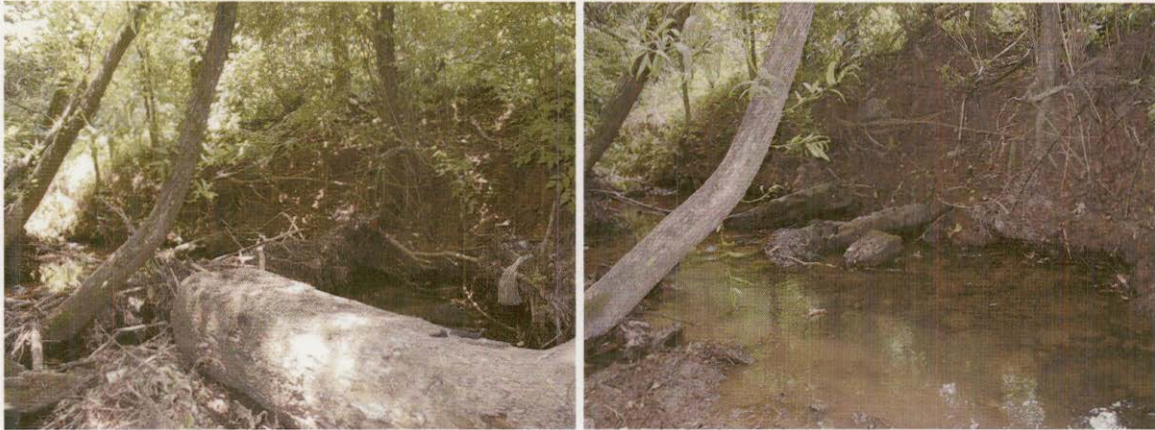
N 35°57.078'
W 083°53.699'

You can see in the photo that this weir had a large fallen tree through the center. Smaller woody debris built up against the trunk of the fallen tree and the standing tree to the left of the photo. Once again the blockage stretched from bank to bank. First the fallen tree was cut up and removed. Then the smaller woody debris and trash was removed.

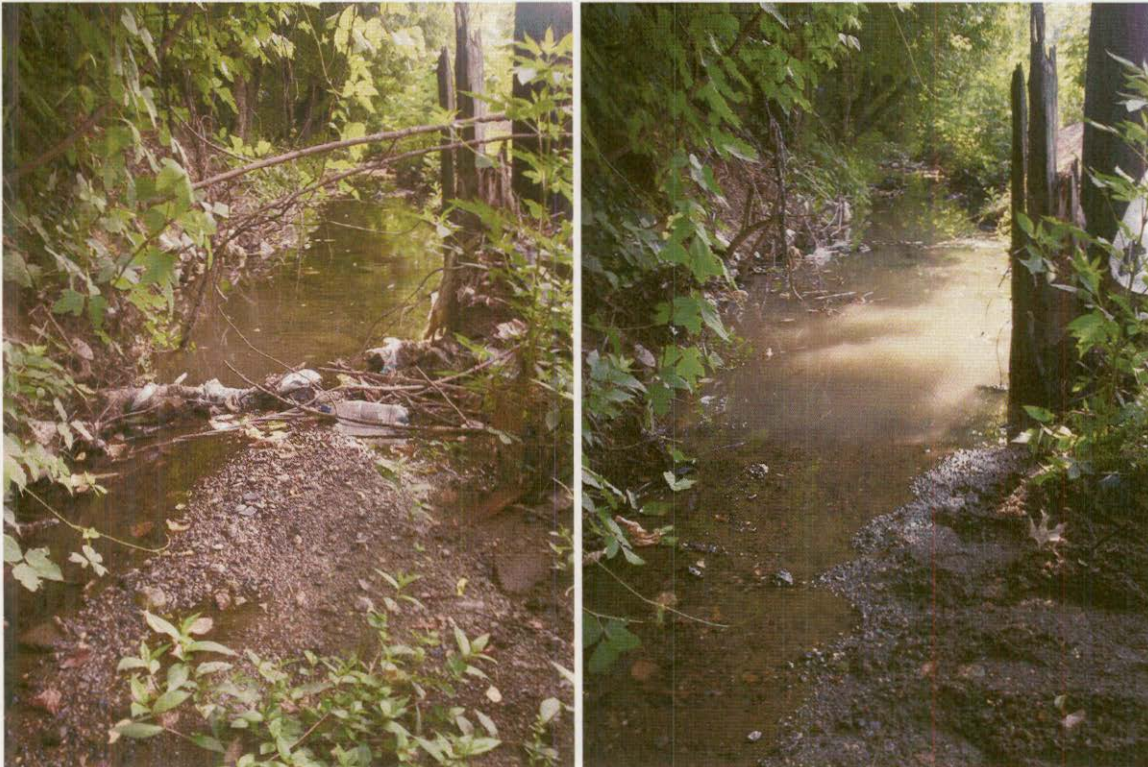
N 35°58.792'
W 083°53.400'

This weir stretched across the entire stream. Deep pooling had begun on the downstream side of the dam. One bag of trash was collected and removed from site. Debris was removed and normal flow restored.

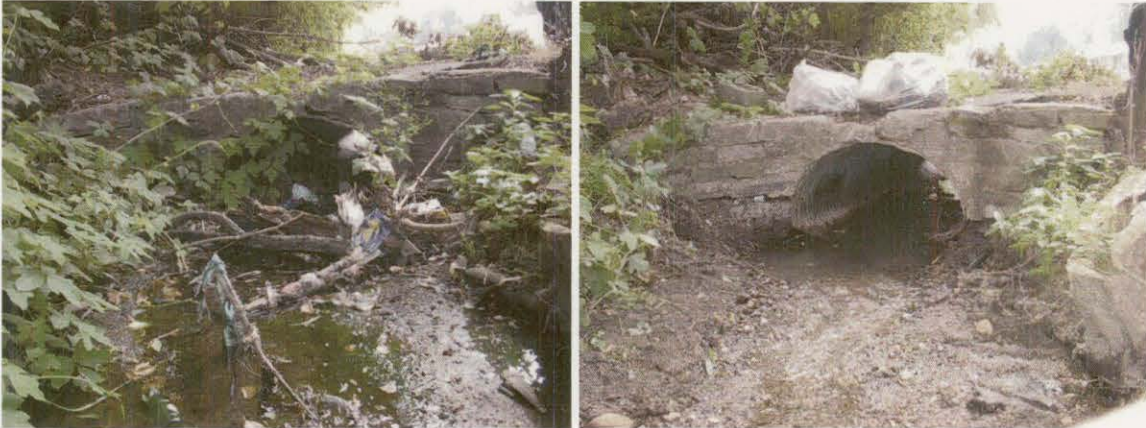
N 35°58.795'
W 083°53.413'

This weir consisted of woody debris and trash. The culvert was full of trash and there was only a trickle of water coming through. Debris was removed and two bags of trash were collected from both the blockage and the culvert. The silt that had built up on the upstream side of the dam was dredged and removed. The after photo shows a heavier flow through the culvert.

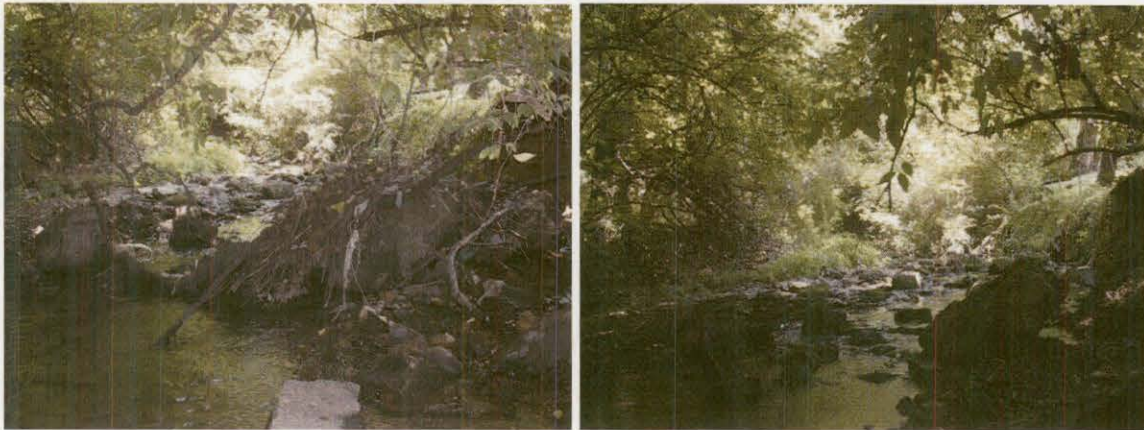
N 35°58.816'
W 083°53.231'

This weir consisted of a large limb that stretched across the creek, a lot of woody debris pinned against the rocks and trash. Using an axe, limbs and roots were cleared. The debris was broken up with a mattock and rake. A bag of trash was collected and removed from the site.

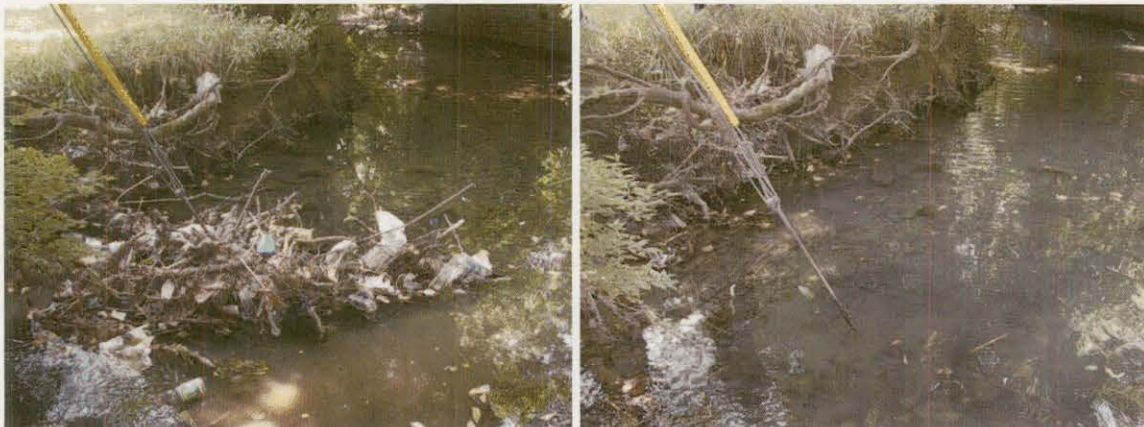
N 35°59.935'
W 083°53.264'

Woody debris and trash pinned against this guy-wire to create a weir that blocked approximately 70% of the creek, diverting flow to the west bank and creating heavy erosion. Debris was removed and one bag of trash was collected and removed from site.

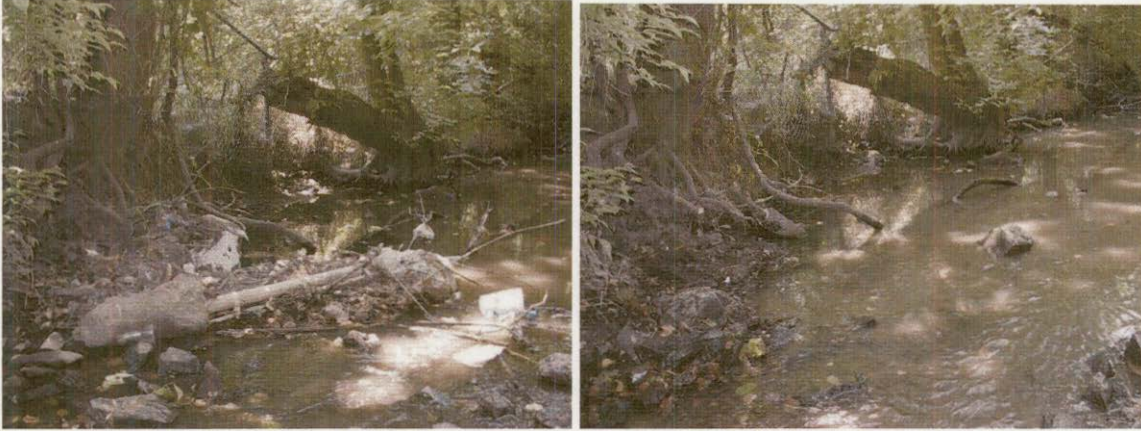
N 35°58.922'
W 083°53.255'

This weir consisted of a galvanized fence post with a roll of chain link fence and concrete footer still attached, Steel framework, mesh wire, woody debris and trash. Approximately 80% of the creek was blocked and stream flow was diverted to the west bank. The fence post was removed. The mesh wire and framework was dug out and removed using a mattock. Debris was removed and one bag of trash was collected and removed. Using shovels silt was dredged and natural flow restored.

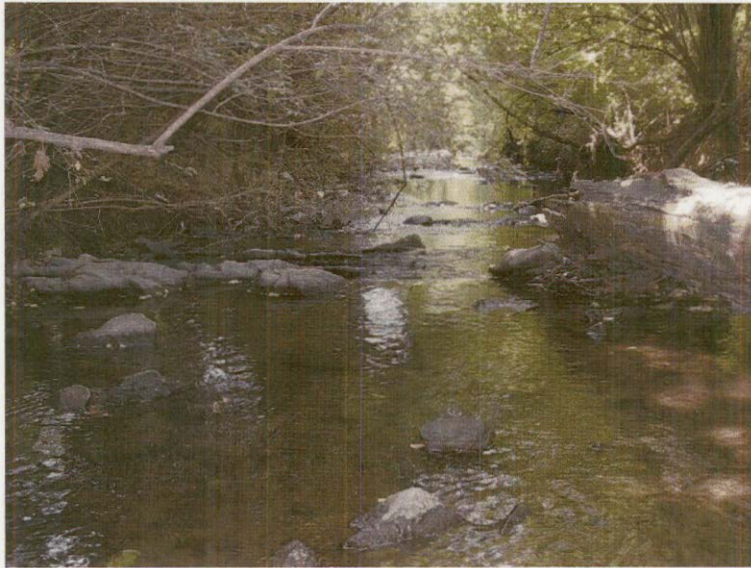
N 35°58.475'
W 083°53.169'

This weir consisted of woody debris and trash. Debris had pinned against rocks and the large tree to the left of the photo. The crew removed debris and one bag of trash was collected and removed from site. Staff members Jake Hudson and Scott Wilson later returned with timberjacks and moved the tree further out of the way.

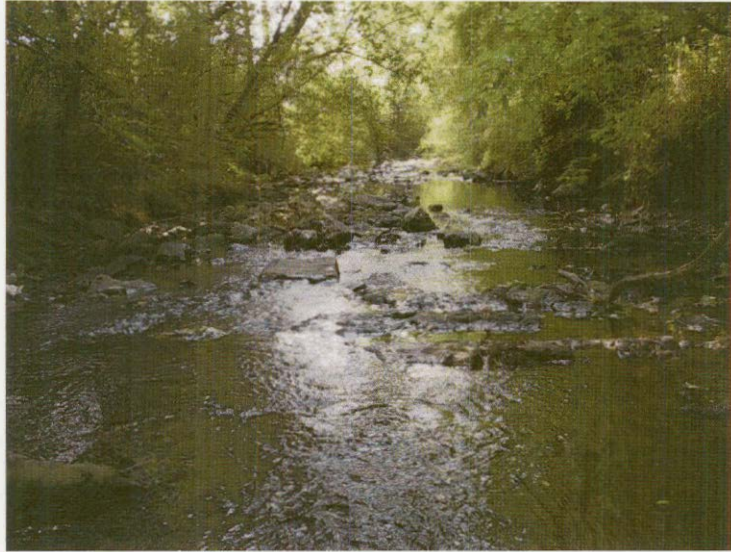
N 35°58.473'
W 083°53.170'

This weir consisted of woody debris and trash. About 60% of the creek was blocked. Debris was broken up and removed. One bag of trash was collected and removed from site.

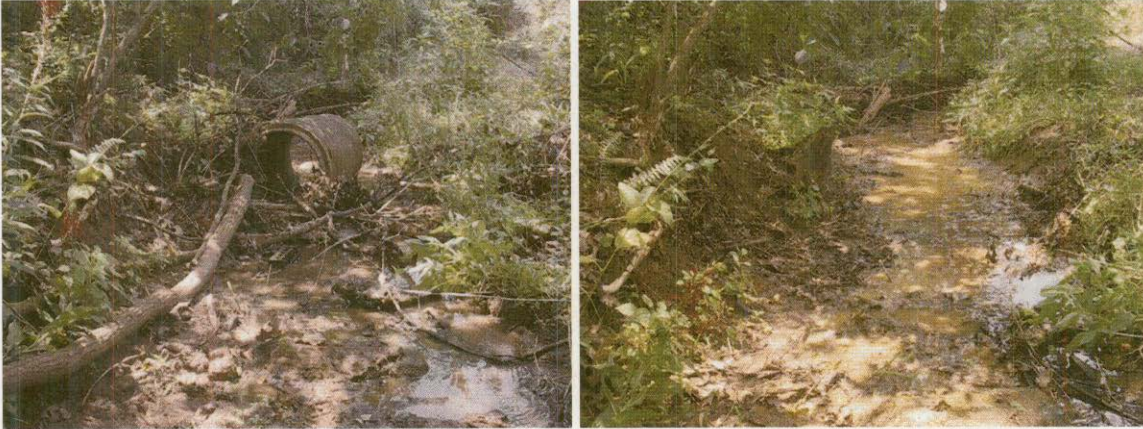
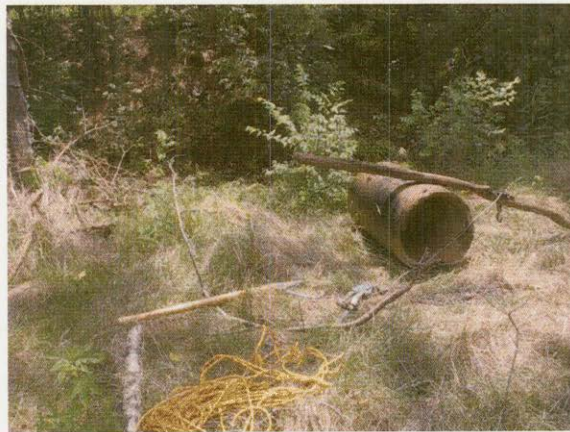
N 35°59.973'
W 083°59.481'

This weir consisted of a 2' diameter concrete culvert, several bricks, and woody debris. The culvert was removed using a come along and timber jack. Then the bricks and debris were removed.

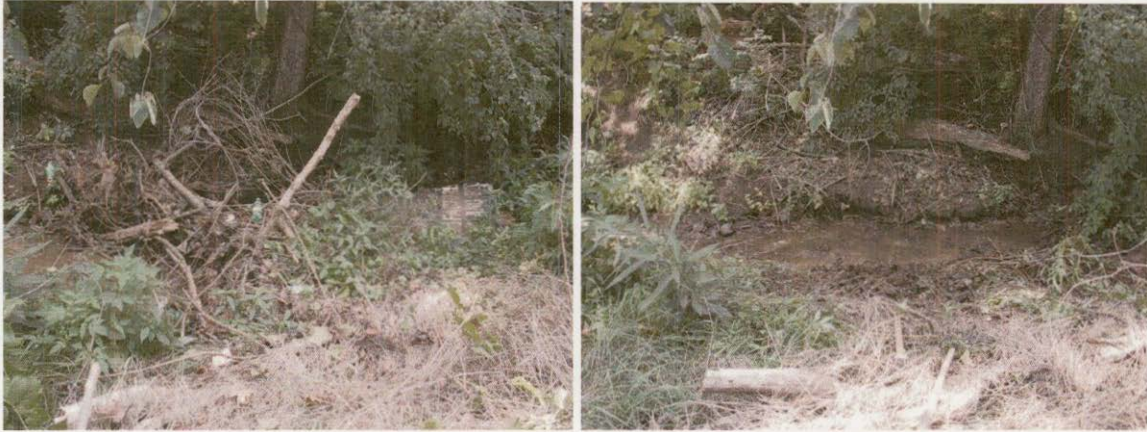
N 35°59.973'
W 083°59.480'

This blockage was made up of woody debris, bricks, trash, and a 4'x 8' metal sign. The debris was removed. The trash and metal sign were collected and removed from site.

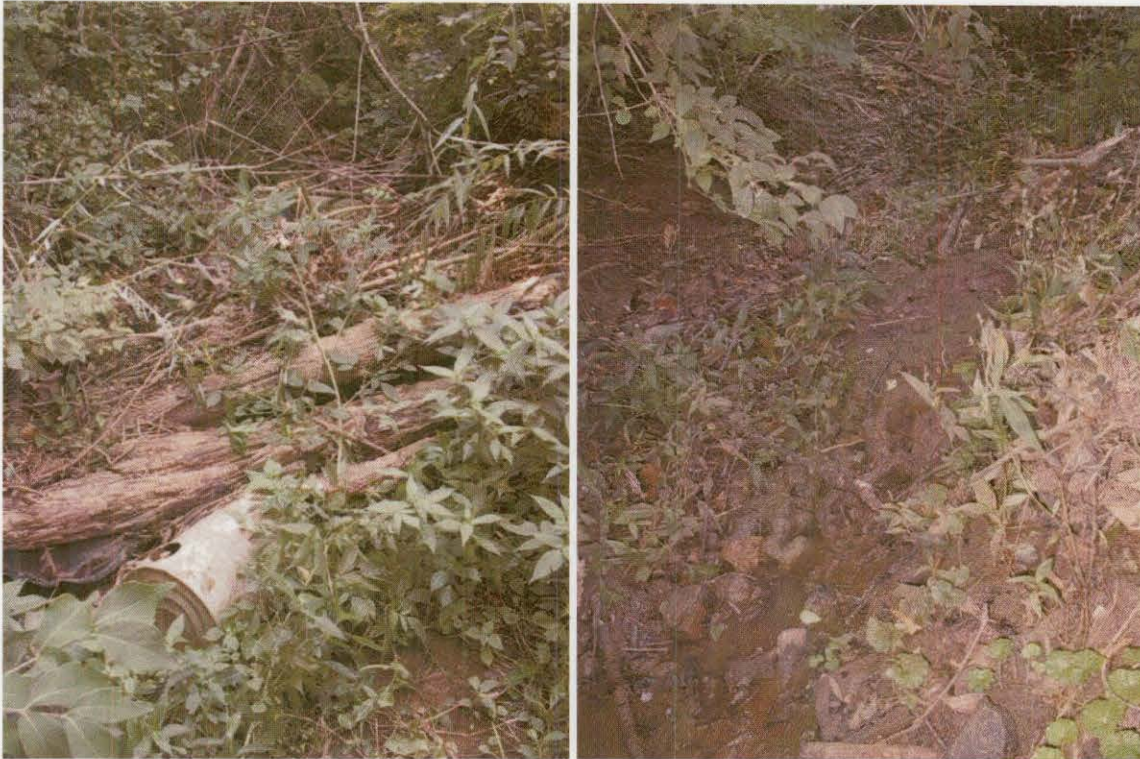
N 35°59.920'
W 083°59.481'

This weir was a combination of large logs, trash and clippings. It seemed as though this blockage had been in place for a long time. The water was forced underground and resurfaced again just past the weir. All of the logs and debris were removed. The threat of flooding was reduced, and with the aid of rain, the flow should be restored.
