THE CITY OF KNOXVILLE TENNESSEE

NPDES Permit Annual Report

National Pollutant Discharge Elimination System
Stormwater Discharge Permit TNS068055
July 1, 2021 - June 30, 2022

Phase I Medium Municipal Separate Storm Drain System (MS4) Annual Report

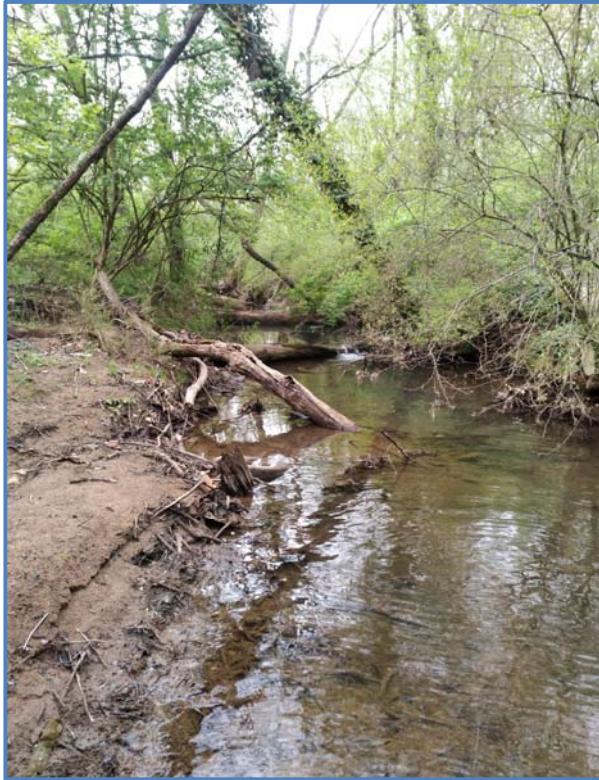
Photo: 1DU

Manmade Modifications:	Channelized	Bridge	Dam	
Sediment Deposits:	High	High	High	
Sediment Type:	Silt	Mud	Clay	
Turbidity:	Slight	Notes:		
Foam/Surface Sheen:	Bacteria	Notes: One small oil sheen, no source found		
Algae:	Moderate	Notes:		
Algae Type:	Filamentous	Green

Observed Human Disturbances:	Slight	Moderate	High	Extreme
Disturbance 1:	Impoundment	Homeless Camps	Riparian Loss	Habitat Alteration
Disturbance 2:	Substrate Alteration		Channelization	
Disturbance 3:			Garbage;Trash	
Disturbance 4:			Sedimentation

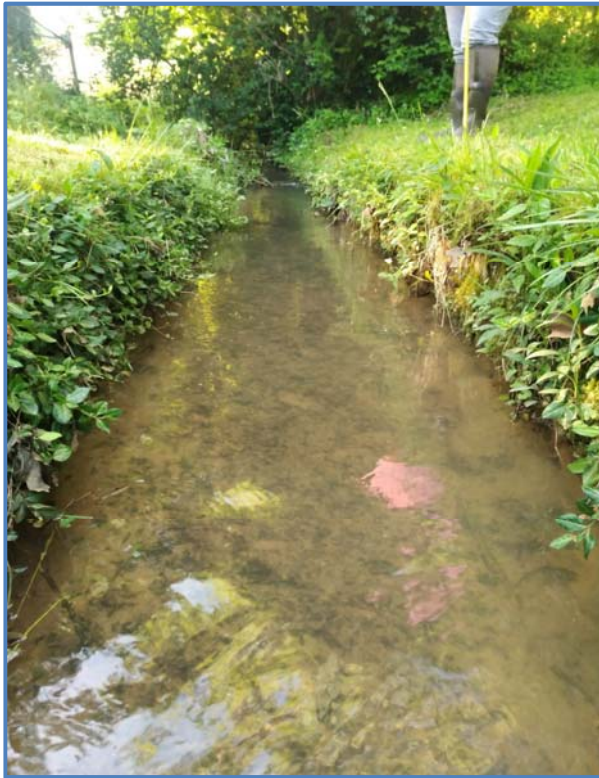
Photo: 5BU

Lower middle upper sections of this reach have distinctive characteristics to themselves. The lower reach is residential and lawns. The middle is wooded, heavily silted, almost to the point of creating a dead zone. The siltation was such that it significantly impacted bug habitat, no fish were seen, only snails observed. Upper reach was wooded, had cobble and bedrock in the substrate to the source, a spring. Bank height throughout the residential section was fairly consistent, about 24 inches or less. Through the middle and upper reach the channel had more sinuosity, with varied bank heights, one side being high one side being low, typically throughout, ie. there was a height differential of the left and right bank, alternating. High water mark varied throughout reach due to channel width and obstructions.

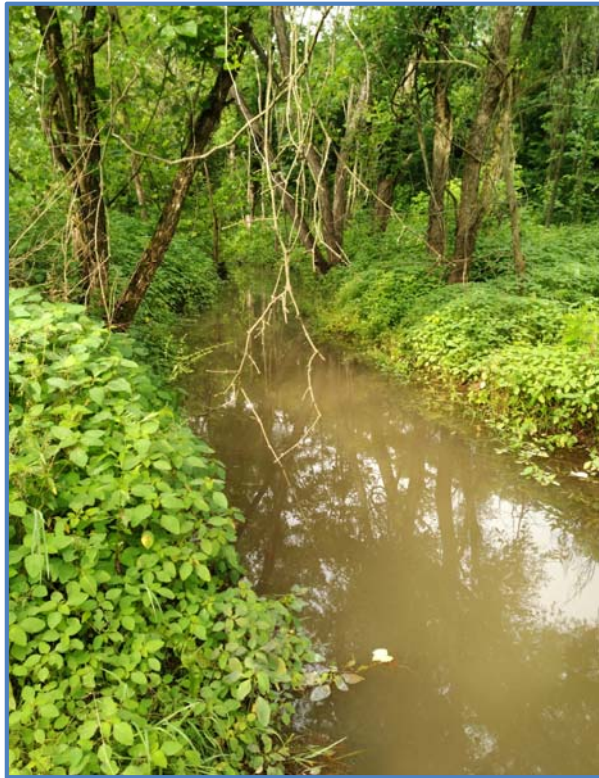
Photo: 6DU

One small beaver dam observed at upper end of reach. This reach is part of the Witherspoon property, and sediment is contaminated with PCBs. There is a significant amount of marble scattered throughout the riparian zone and within the creek adjacent to Candor Marble Mill (historical). A portion of the reach has historical industrial/manufacturing property that is growing back to nature, but is not an original buffer. Bank heights were commonly 2-4 ft throughout the reach. High water mark varied throughout reach due to channel width and obstructions.
