**Subject: Final Phase II Environmental Site Assessment Report  
McClung Warehouses  
Knoxville, Knox County, Tennessee  
EPA Contract No. EP-S4-14-03  
Technical Direction Document No. TT-06-006**

**FINAL  
PHASE II ENVIRONMENTAL SITE ASSESSMENT REPORT**

**MCCLUNG WAREHOUSES  
KNOXVILLE, KNOX COUNTY, TENNESSEE**

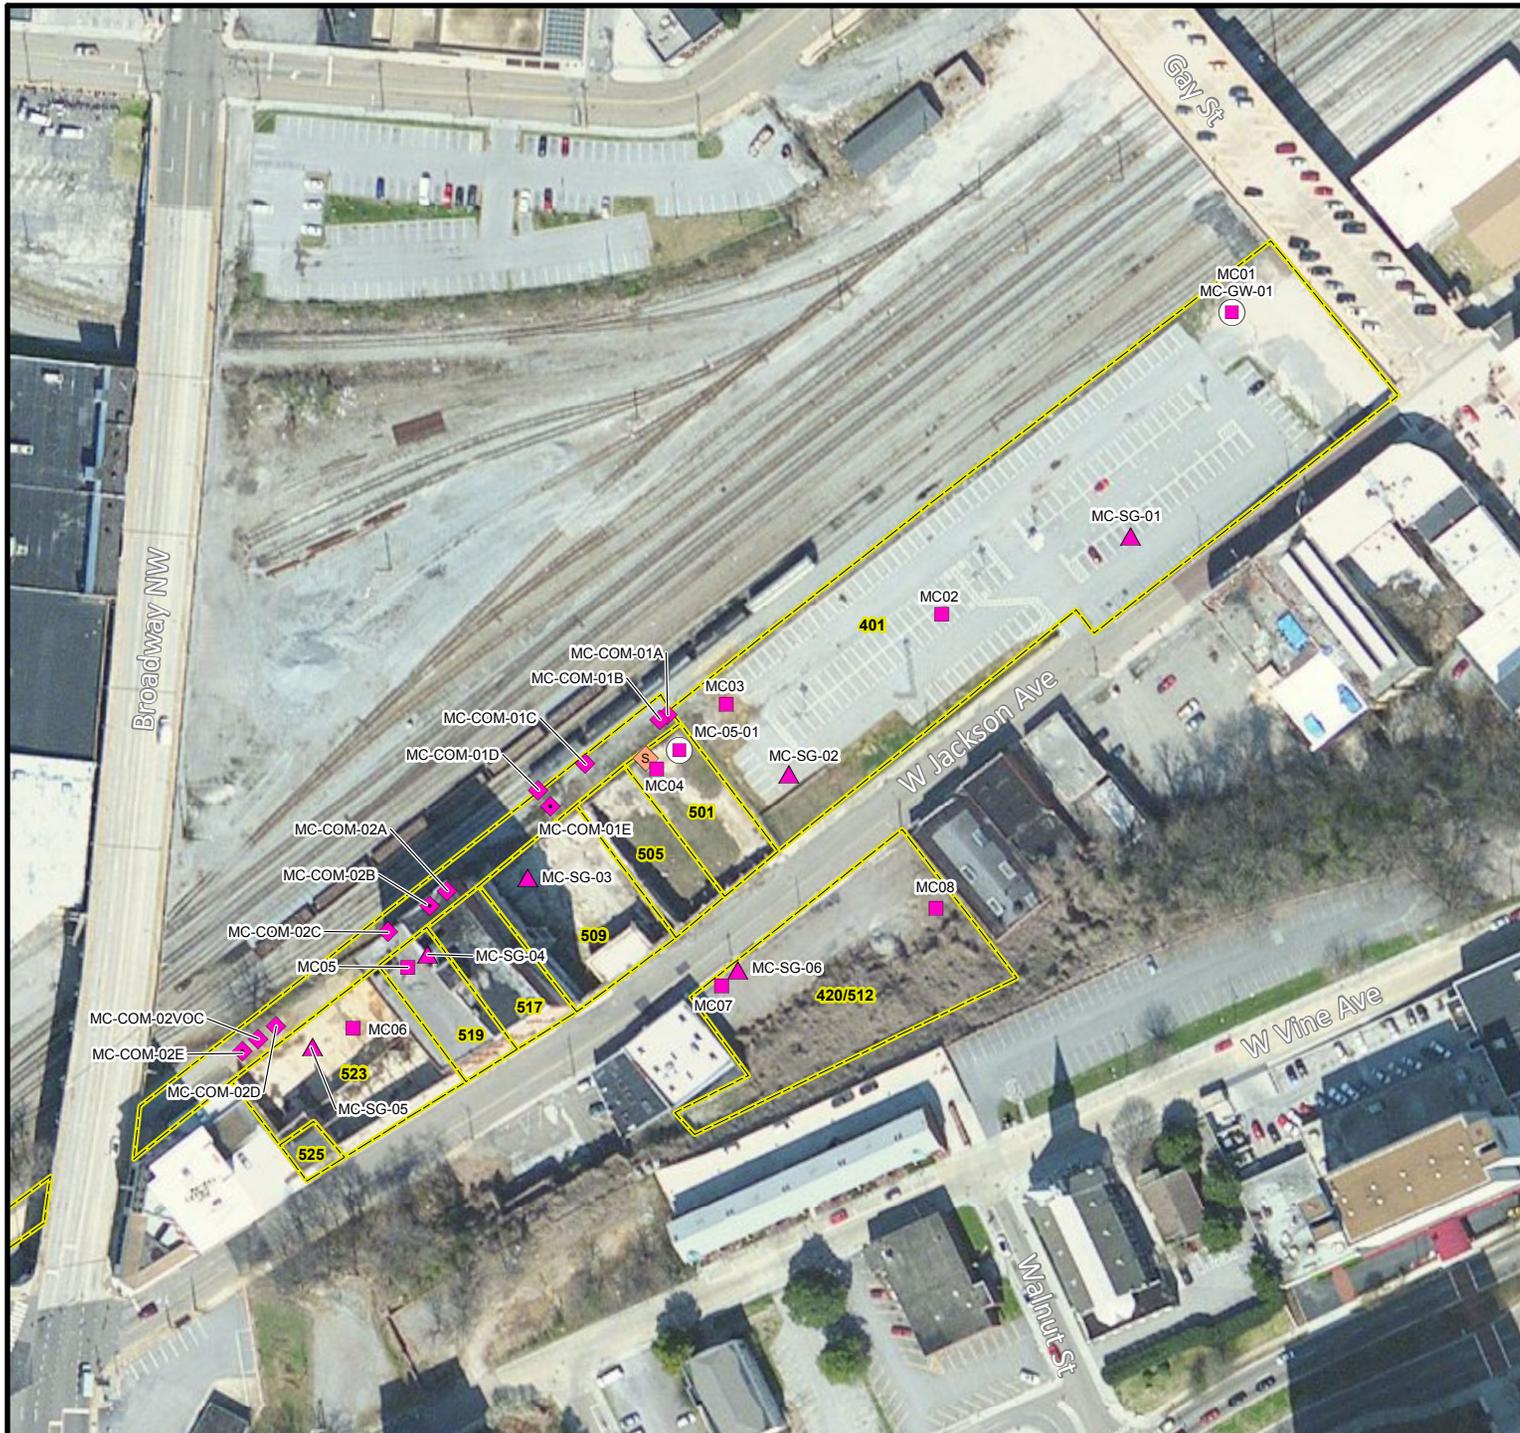
- Soil Boring Sample
- ◆ 5-point Soil Composite Sample
- ▲ Soil Gas Sample
- Soil Boring and Groundwater Samples
- ◇ Stain
- Site Location

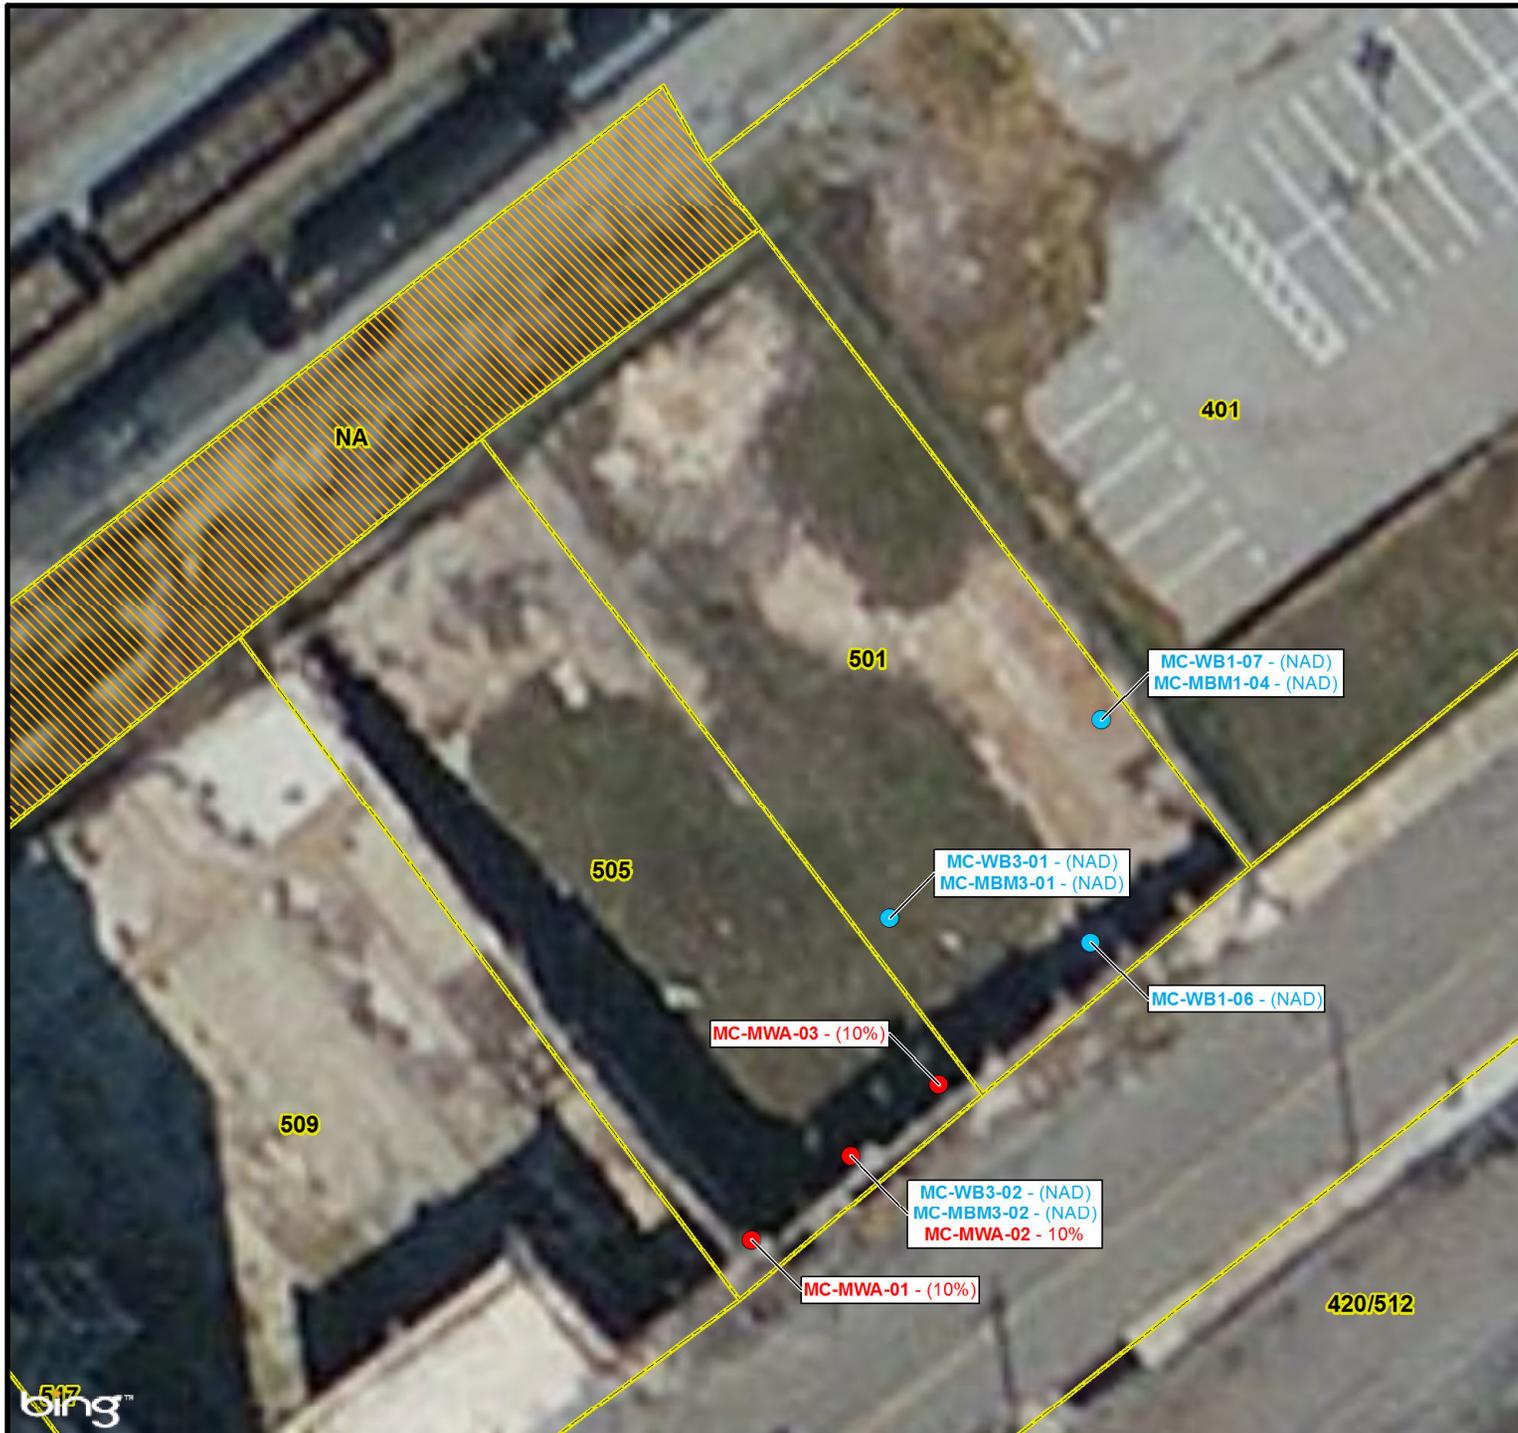
**FIGURE 4A**

- No Asbestos Detected
- Asbestos-Containing Material
- Parcel Boundary
- Option Tract

Of the 53 ACM samples collected, six samples contained asbestos at greater than 1 percent. These samples were collected from wall adhesive (HA4) and roof flashing (HA9) found at 505 and 523W. Jackson Avenue.

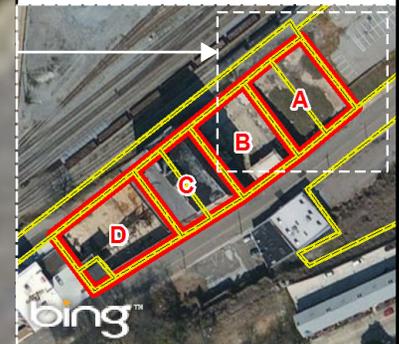
Suspected ACM sampling was conducted in accordance EPA Region 4 SESD FBQSTP *Bulk Sampling for Asbestos*, SESDGUID-104-R1 (June 2013). Figures 4A through 4D in Appendix A depict the suspected ACM sampling locations. Table 2 in Appendix B lists the number of suspected ACM samples, the material descriptions, the warehouse shell and address, and the location where the samples were collected.

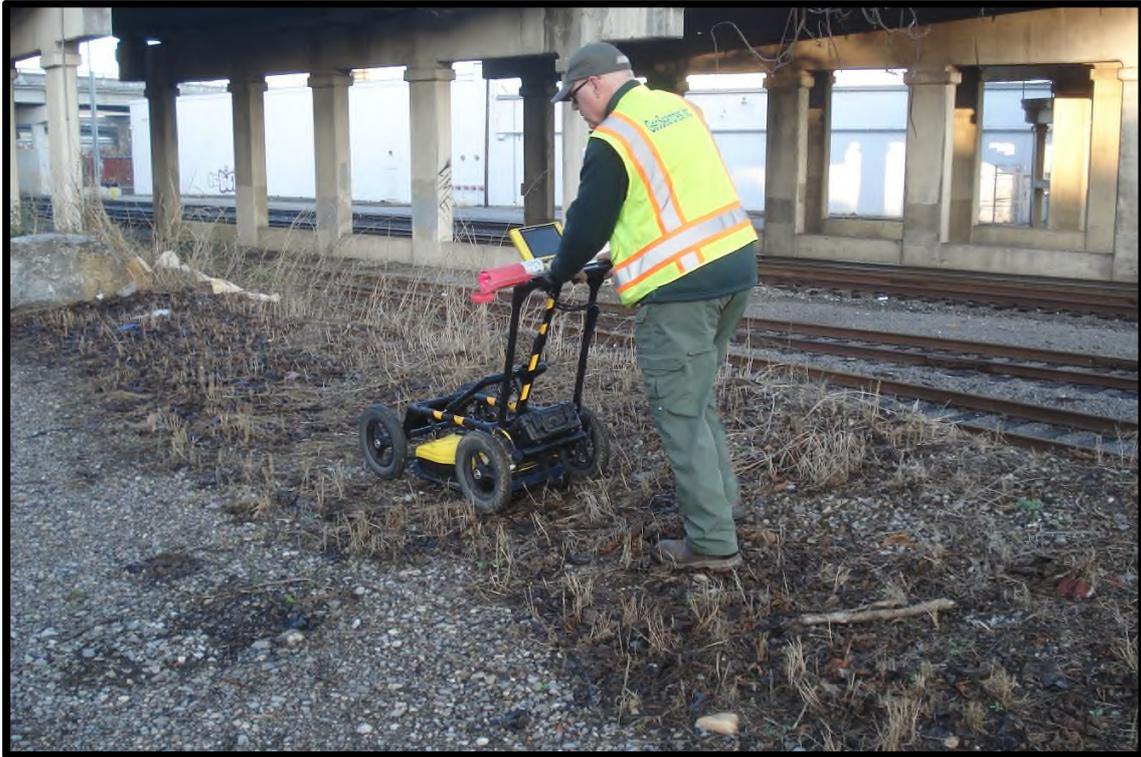
**OFFICIAL PHOTOGRAPH NO. 1**  
**U.S. ENVIRONMENTAL PROTECTION AGENCY**

**Subject:** View of geophysical survey being conducted on the portion of the site located at 523 and 525 W. Jackson Avenue in Knoxville, Knox County, Tennessee, the McClung Warehouses site. The ground-penetrating radar (GPR) survey is being conducted before Phase II Environmental Site Assessment (ESA) activities are initiated.

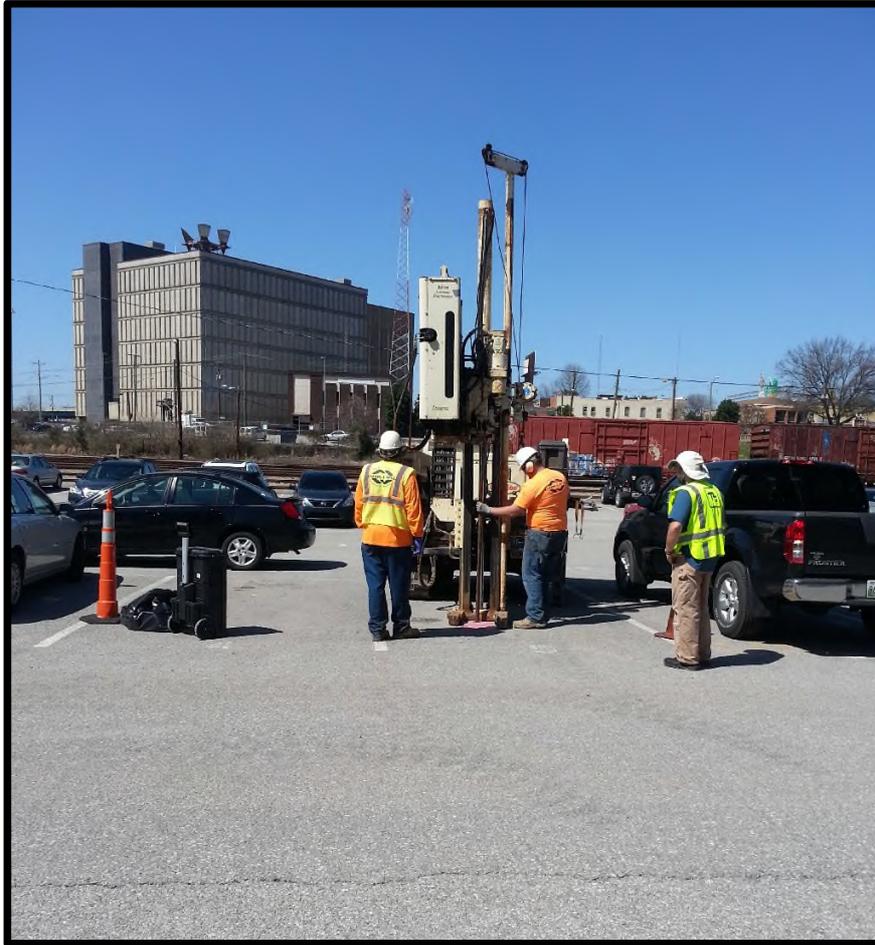
**OFFICIAL PHOTOGRAPH NO. 2**  
**U.S. ENVIRONMENTAL PROTECTION AGENCY**

**Subject:** View of direct-push technology drilling conducted at soil gas sampling location MC-SG-01.

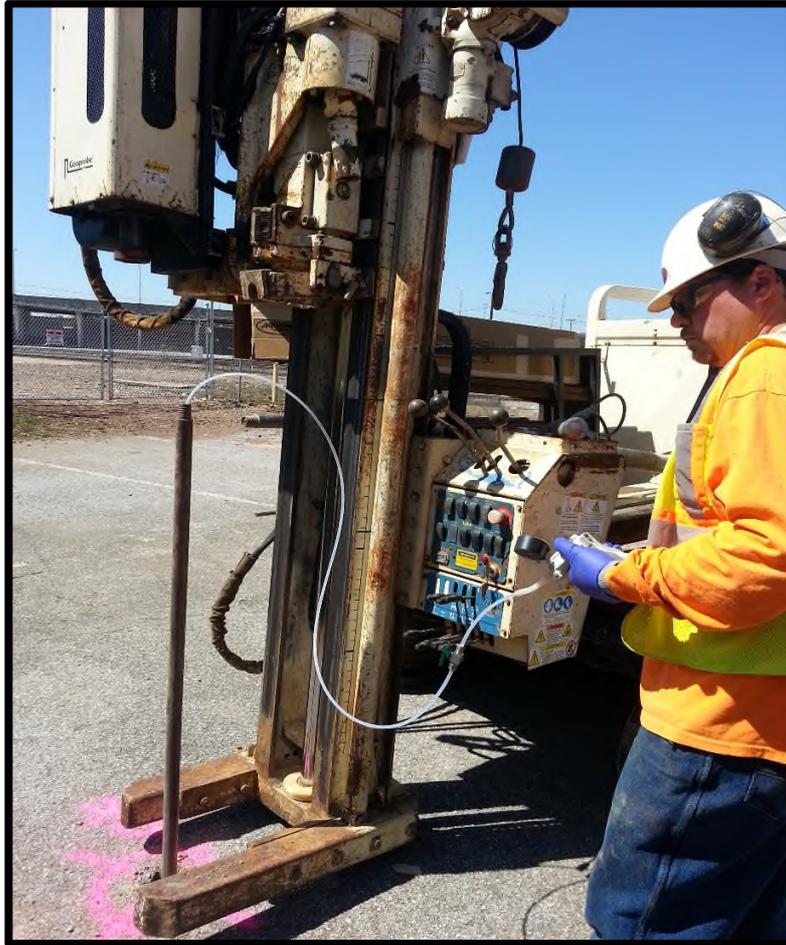
**OFFICIAL PHOTOGRAPH NO. 3  
U.S. ENVIRONMENTAL PROTECTION AGENCY**

**Subject:** View of driller purging soil gas line at sampling location MC-SG-02 before samples were collected.

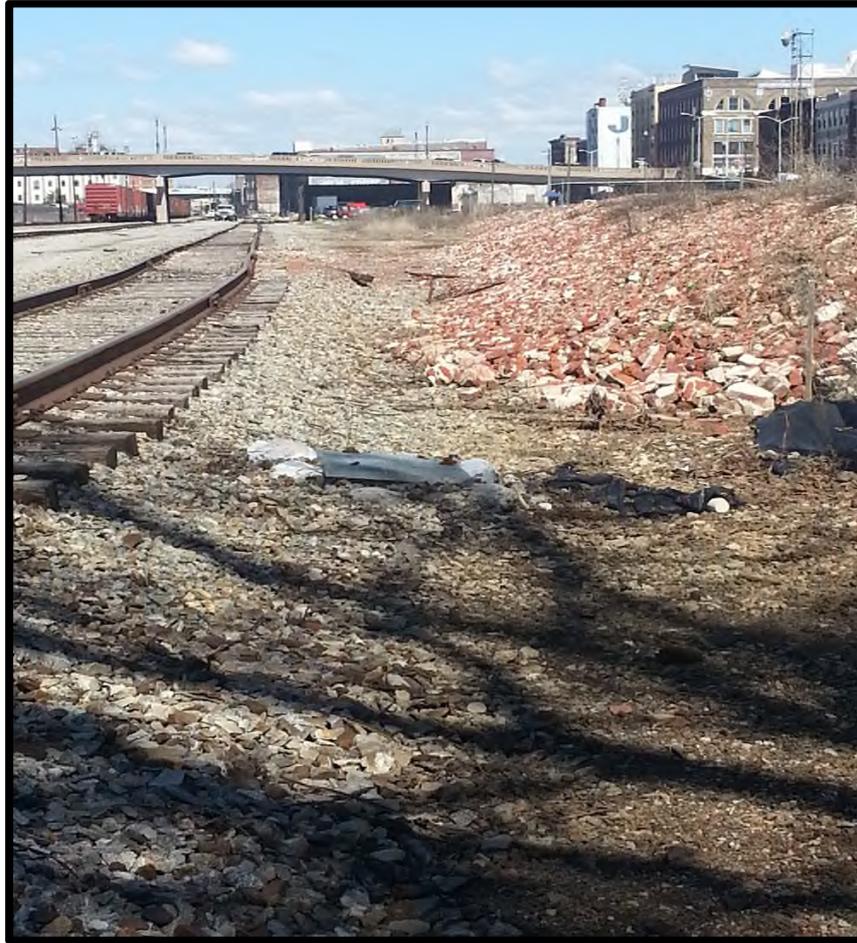
**OFFICIAL PHOTOGRAPH NO. 6**  
**U.S. ENVIRONMENTAL PROTECTION AGENCY**

**Subject:** View of the 5-point composite area for sampling location MC-COM-02. The 5-point composite area is in the Option Tract of the site, located north of 523 and 525 W. Jackson Avenue.

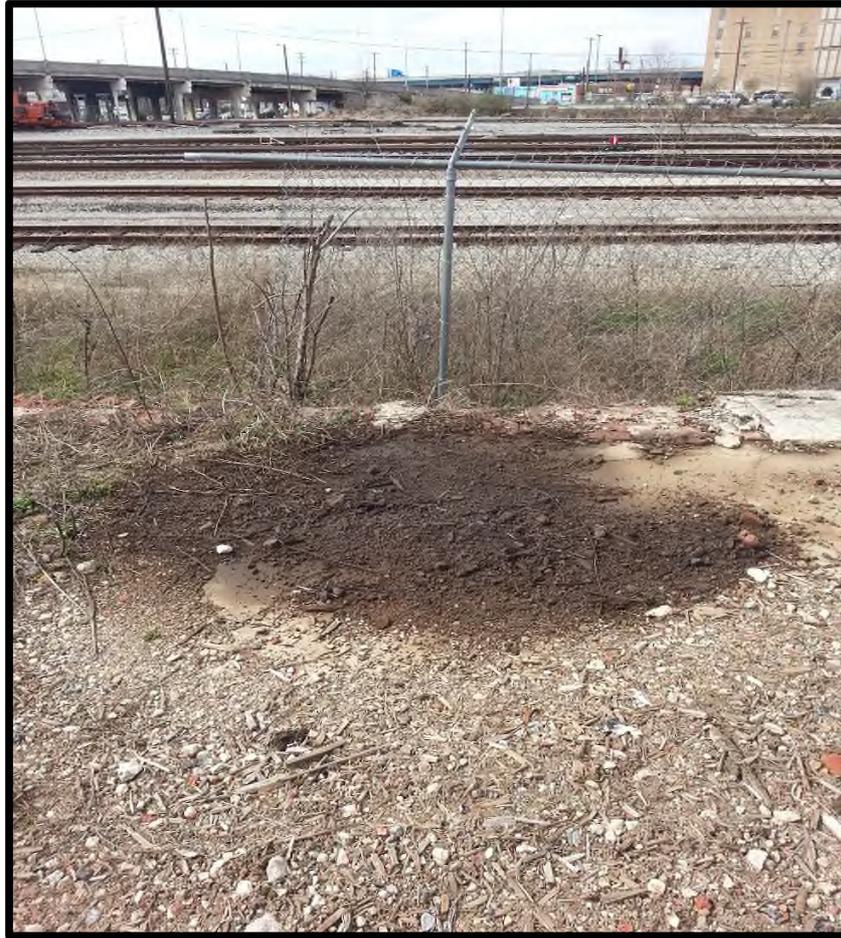
**OFFICIAL PHOTOGRAPH NO. 7**  
**U.S. ENVIRONMENTAL PROTECTION AGENCY**

**Subject:** View of stained concrete on the foundation of 501 W. Jackson Avenue. The stain appears to be associated with a minor leak or spill from previous operations. Based on the small size and localized nature of the staining since it is confined to the concrete, it is considered *de minimis*.

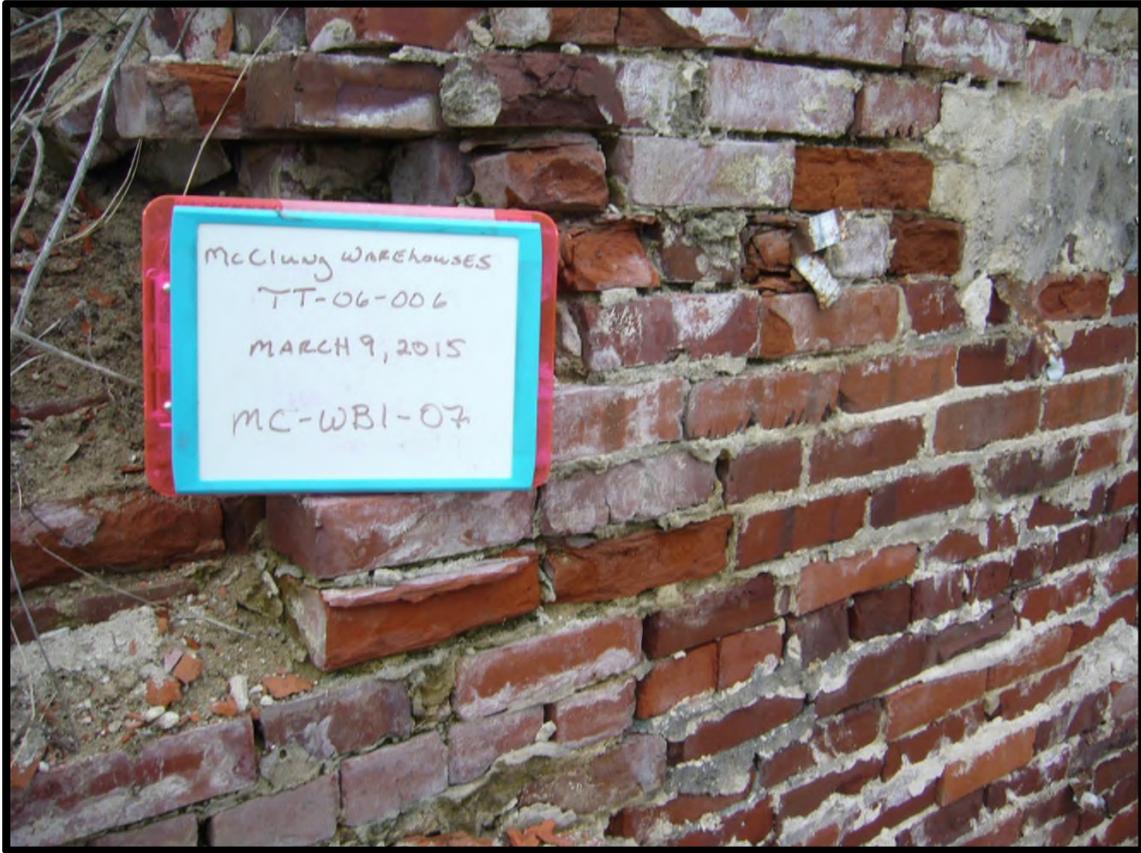
**OFFICIAL PHOTOGRAPH NO. 8  
U.S. ENVIRONMENTAL PROTECTION AGENCY**

**Subject:** Suspect asbestos-containing material (ACM) sample MC-WB1-07, collected from the brick wall at 523 W. Jackson Avenue, located in the center of the upper level from the ground.

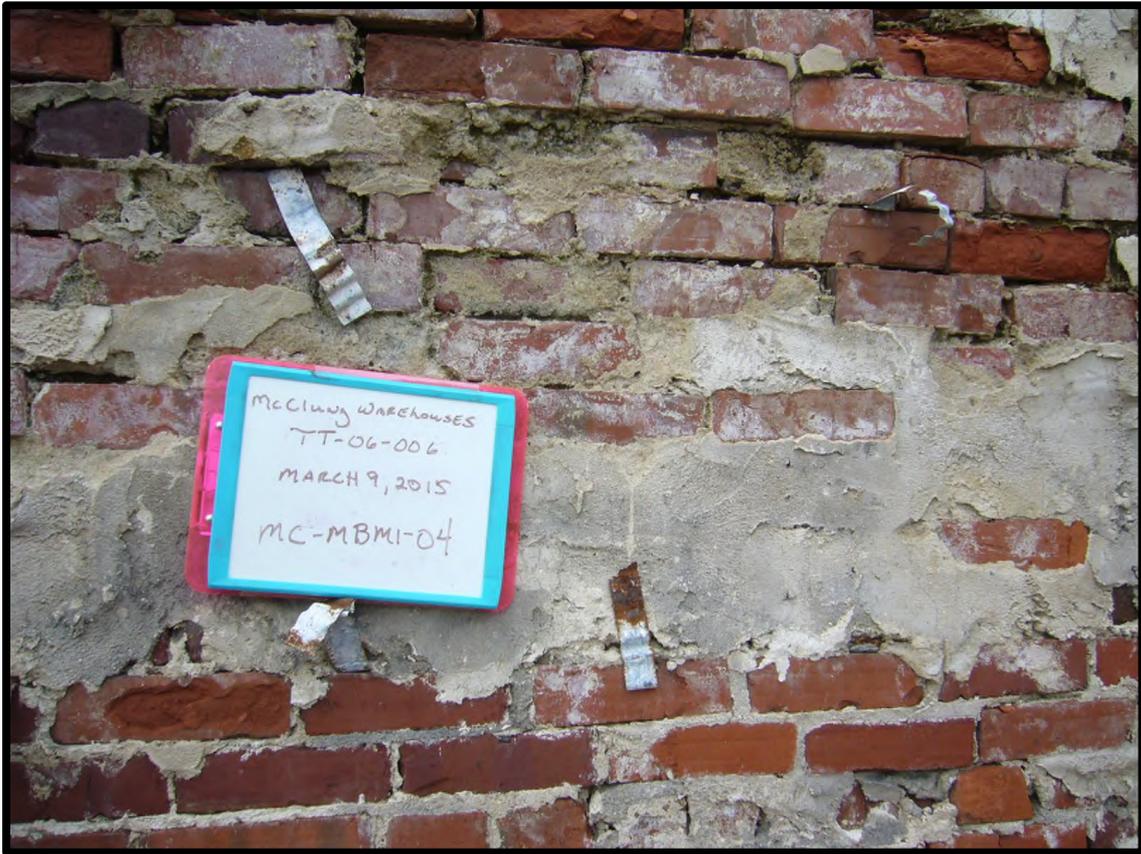
**OFFICIAL PHOTOGRAPH NO. 9**  
**U.S. ENVIRONMENTAL PROTECTION AGENCY**

<b>TDD Number:</b>	TT-06-006	<b>Location:</b>	McClung Warehouses
<b>Orientation:</b>	Not applicable	<b>Date:</b>	March 9, 2015
<b>Photographer:</b>	Paul Prys, Tetra Tech	<b>Witness:</b>	None
<b>Subject:</b>	Suspect ACM sample MC-MBM1-04, collected from brick mortar at 501 W. Jackson Avenue, located at the end of the northeast wall.
