# THE CITY OF KNOXVILLE TENNESSEE

## NPDES Permit Annual Report

National Pollutant Discharge Elimination System  
Stormwater Discharge Permit TNS068055  
July 1, 2010 - June 30, 2011

**RE: City of Knoxville, NPDES MS4 Permit # TNS068055  
2010 – 2011 Annual Report**

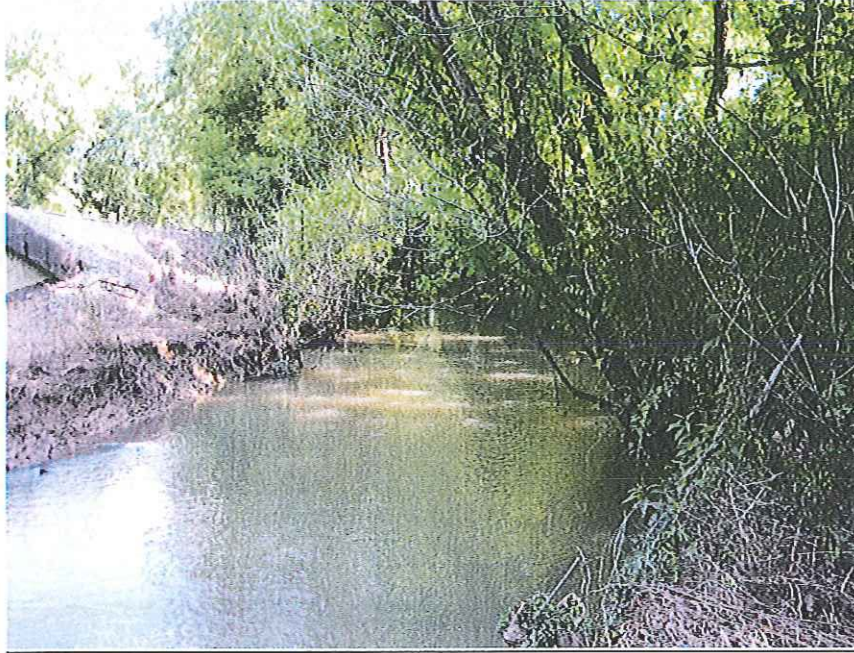
Photo 1. Upper site showing bank failure.

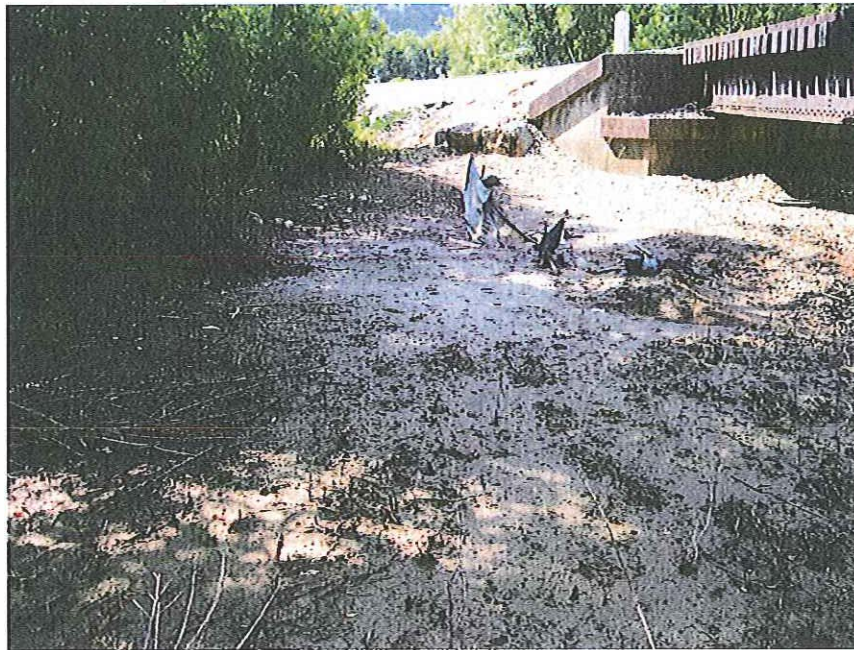
Photo 2. Impacted riparian zone adjacent to the railroad tracks.

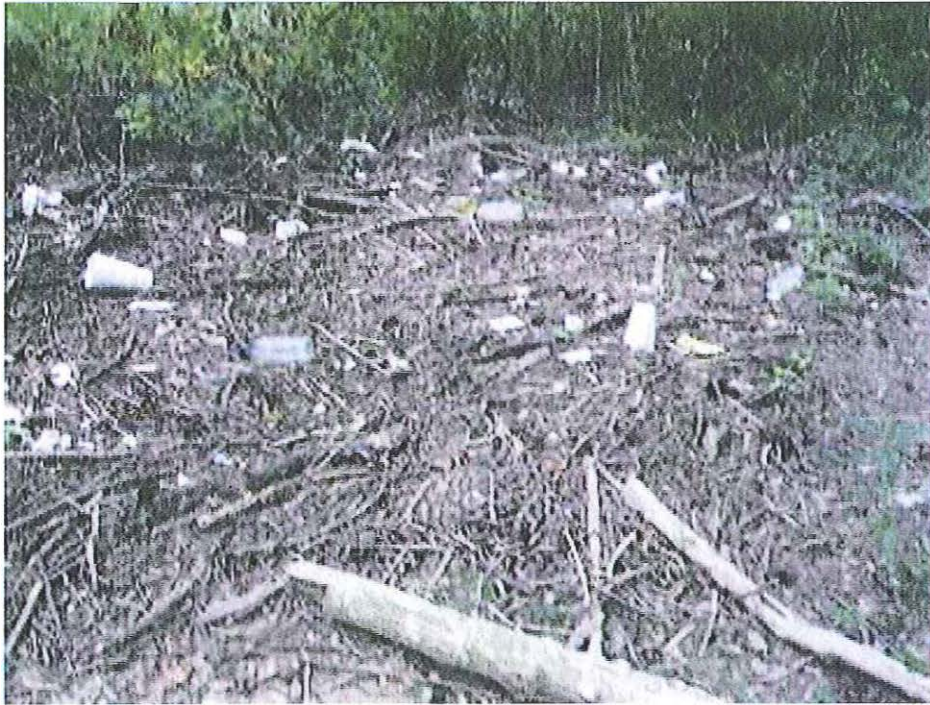
Photo 3. Wrack line with trash located several meters from the stream.

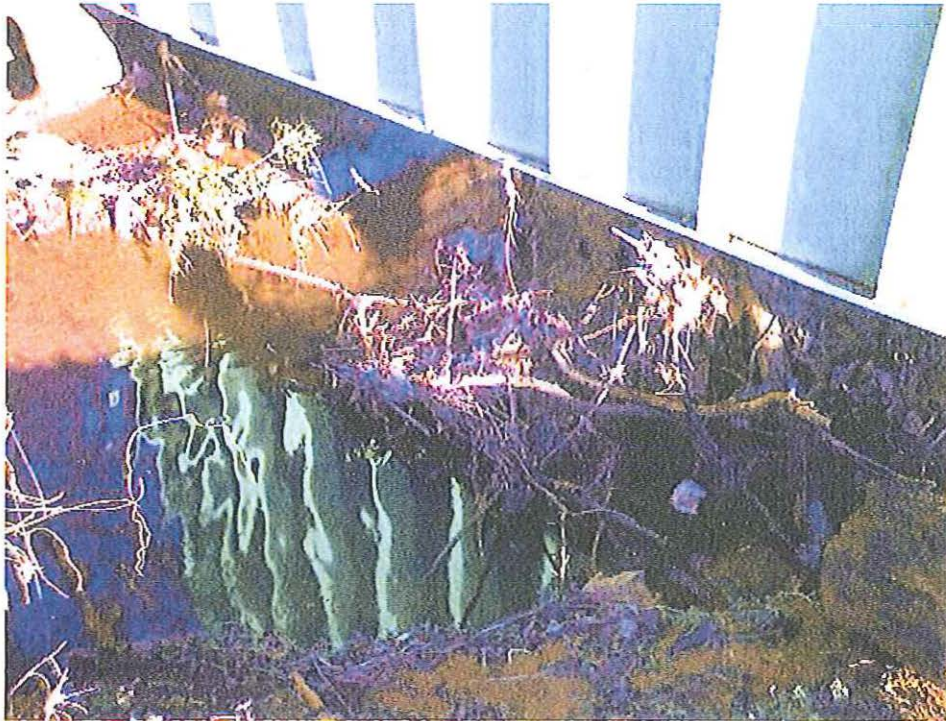
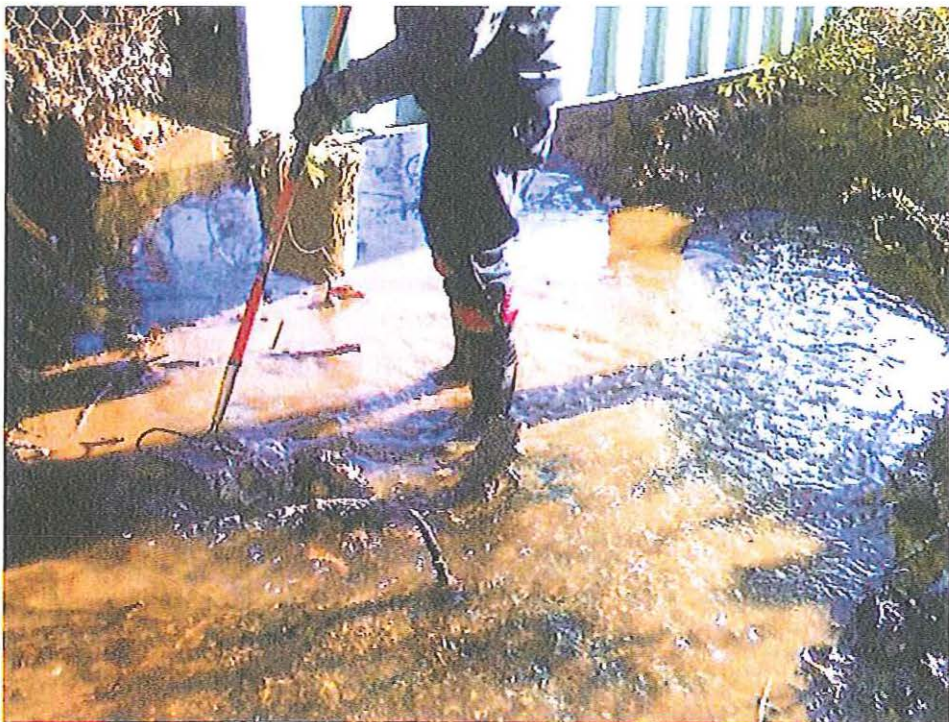
## Goose Creek 01

This weir was reported by the City of Knoxville Stormwater Engineering Department. On December 9, 2010, it was removed by Kirk Forgety, Jake Hudson and Asher Freeman, an Intern. A tree had fallen just upstream of the fence beside 4334 Edington Road, which trapped several logs and trash on the upstream side. Using a machete, rakes and a chain saw, the logs were removed and the trash was placed in bags and removed.

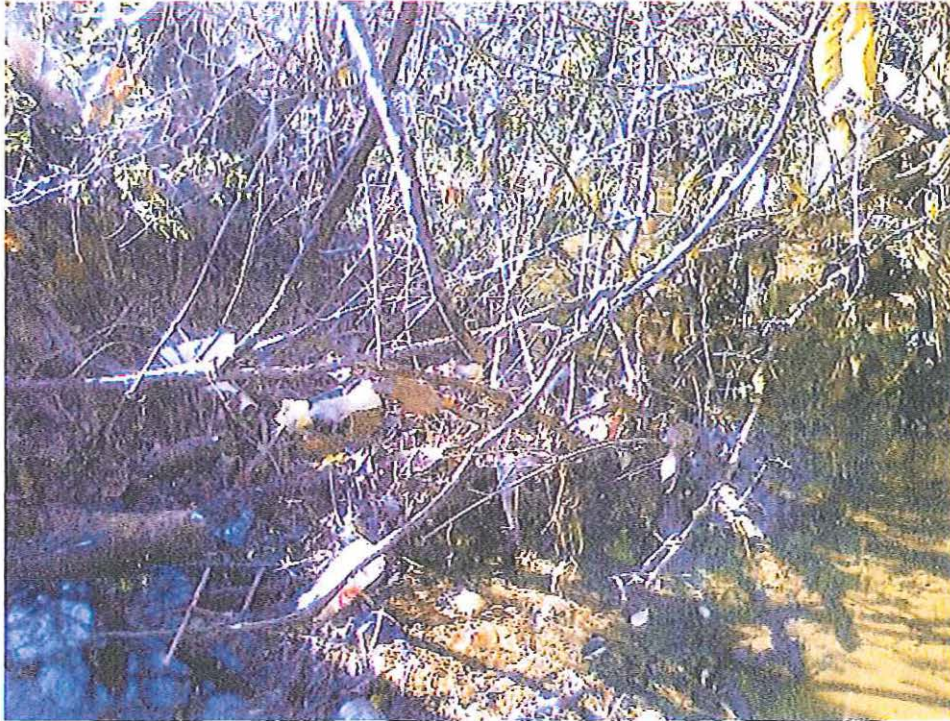
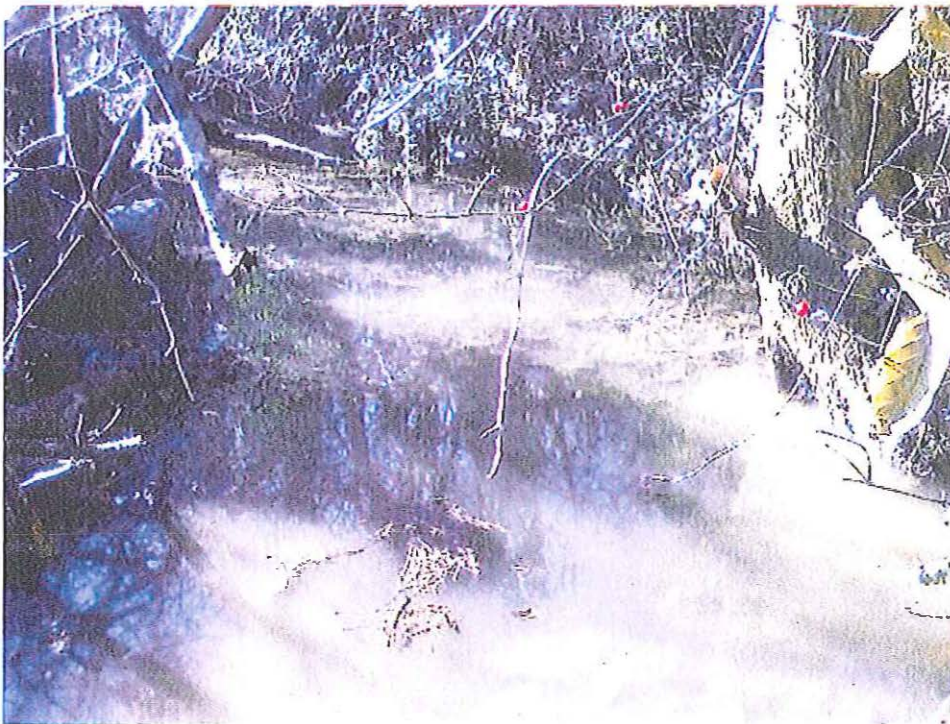
## Goose Creek 02

This weir was reported by the City of Knoxville Stormwater Engineering Department. On December 9, 2010, it was removed by Kirk Forgety, Jake Hudson and Asher Freeman, an Intern. A tree and numerous vines were blocking the stream approximately 100 feet west of Edington Road, which trapped debris on the upstream side. Using a machete, rakes and a chain saw, the logs were removed and the trash was placed in bags and removed.

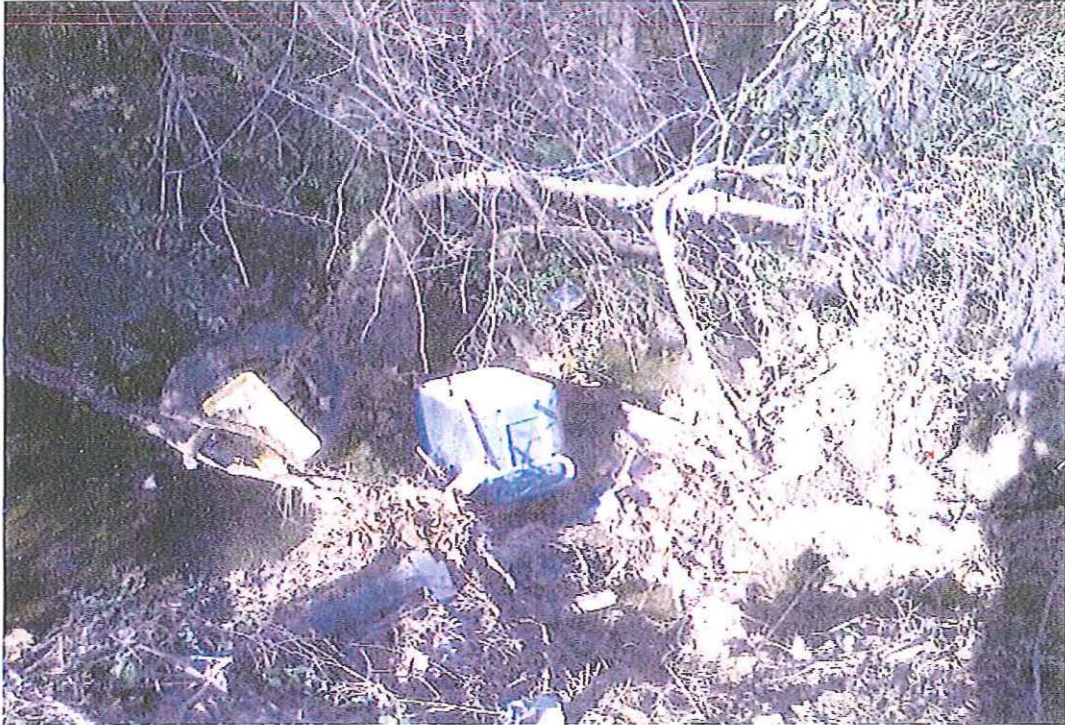
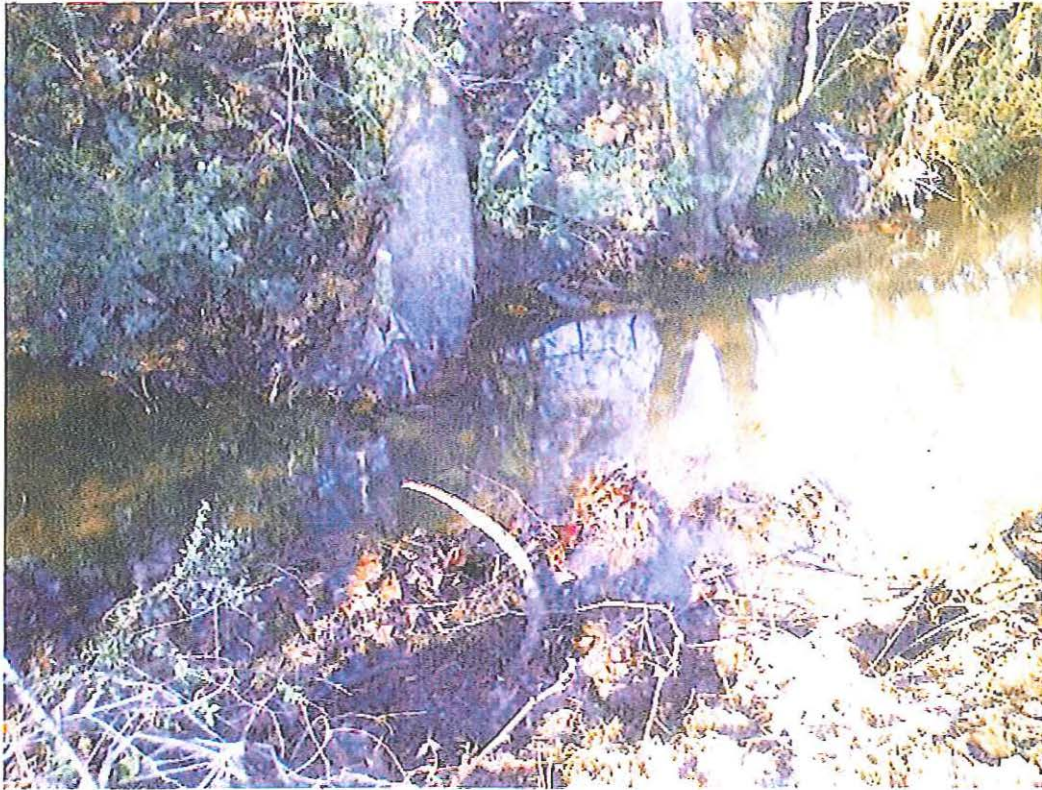
## Goose Creek 03 and 04

This weir was reported by the City of Knoxville Stormwater Engineering Department. On December 9, 2010, it was removed by Kirk Forgety and Asher Freeman. A tree and numerous vines were blocking the stream approximately 180 feet west of Edington Road, which trapped debris on the upstream side. Using a machete, rakes and a chain saw, the logs were removed and the trash was placed in bags and removed.

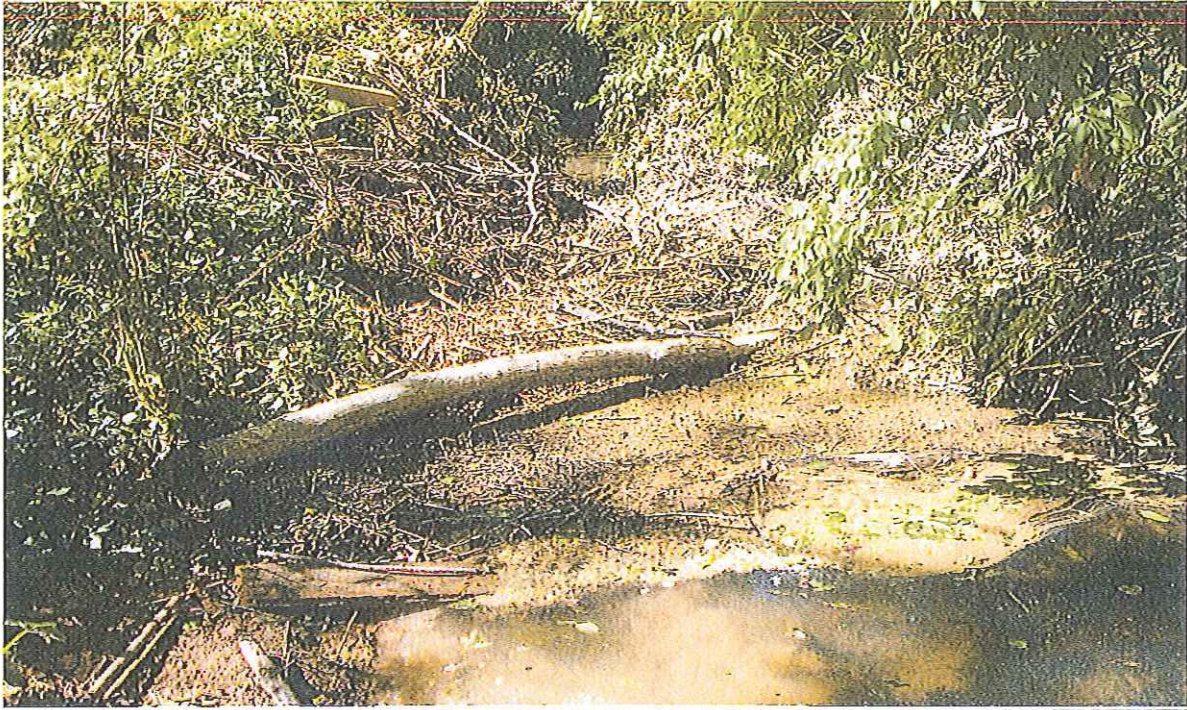
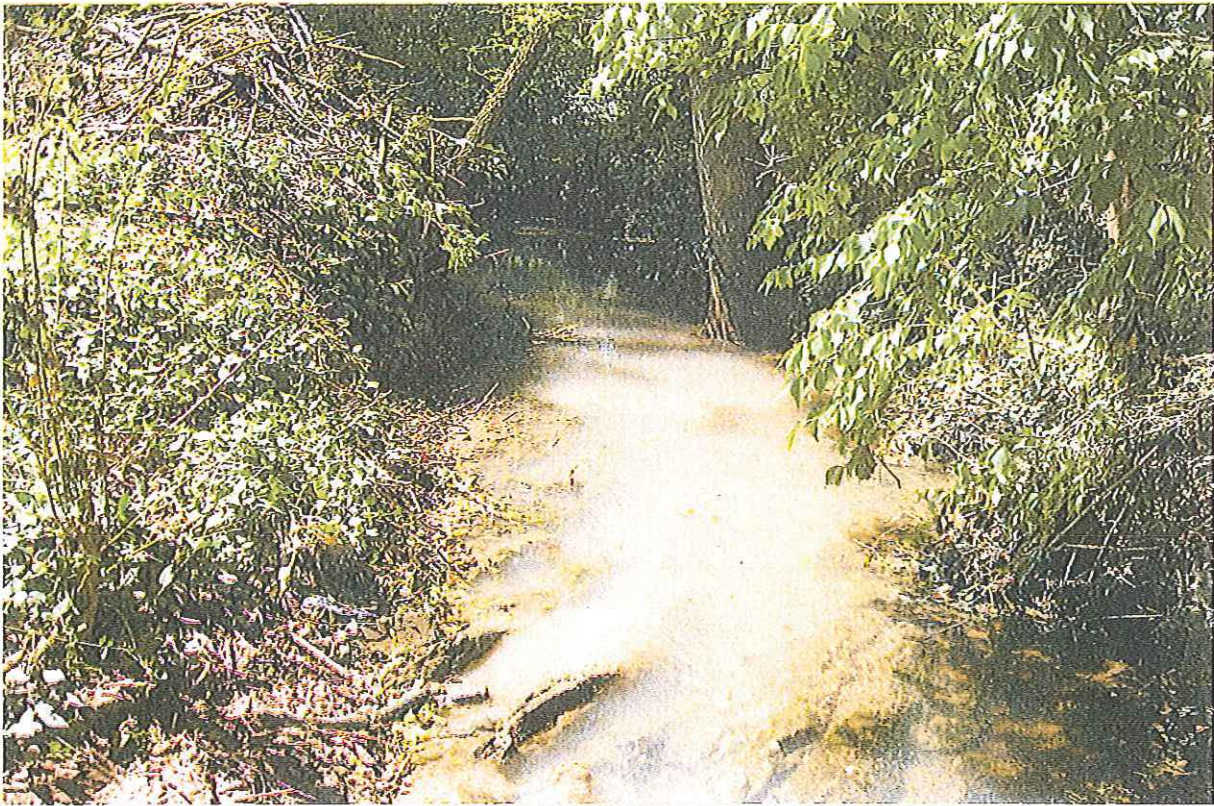
## Knob Creek 01

This weir was reported by the City of Knoxville Stormwater Engineering Department. A small tree had trapped a huge amount of leaf and branch material knocked down by the hail storm of April 27. The stream was blocked and was flooding 4 properties. On May 6, 2011 it was removed by Kirk Forgety and Jake Hudson

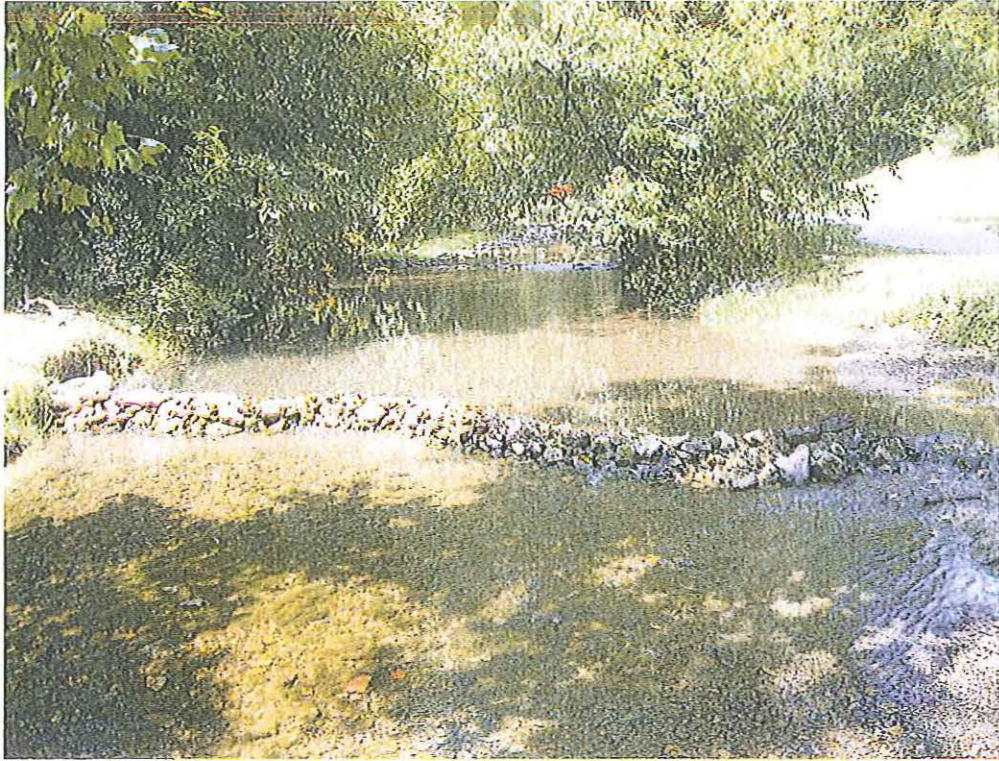
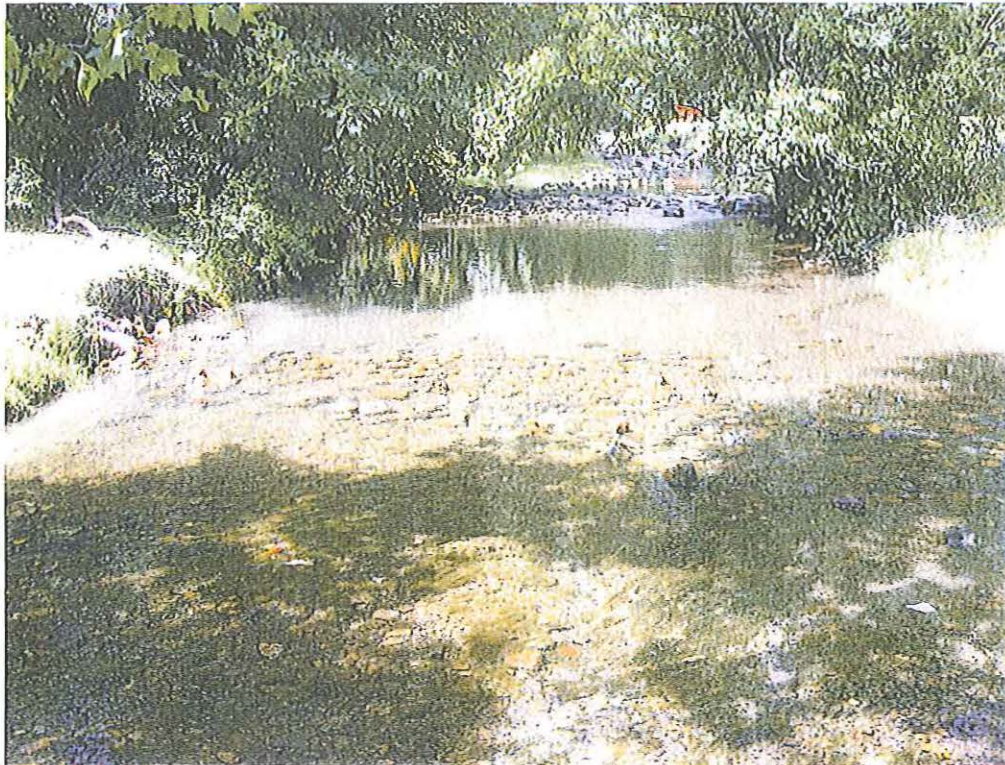
**Love Creek 04**

This weir was found and removed by Kirk Forgety on June 13, 2011. It and the next two were obviously constructed by people, but they are barriers to fish movement and do collect debris.

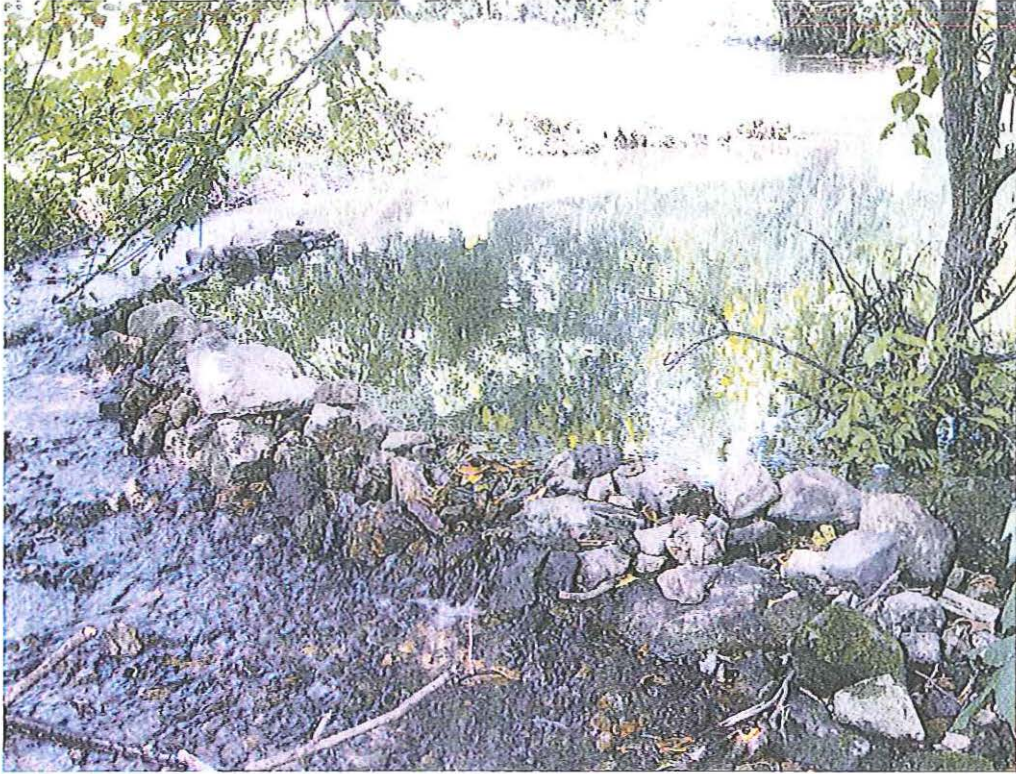
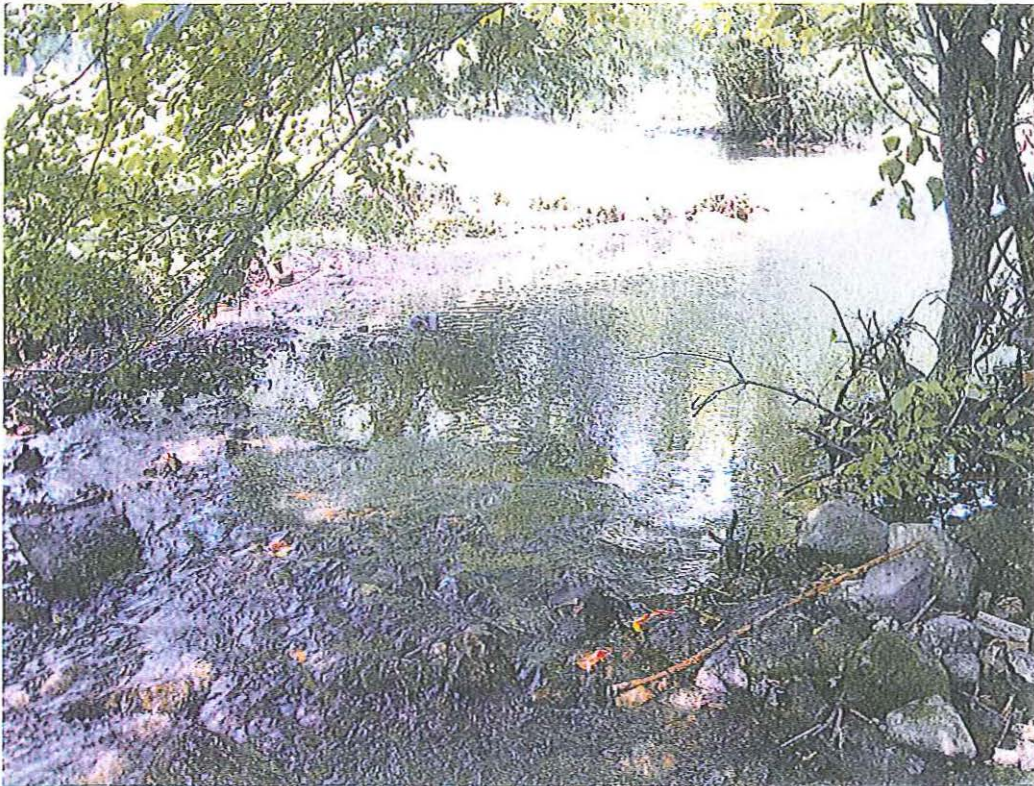
**Love Creek 05**

This weir was found and removed by Kirk Forgety on June 13, 2011.

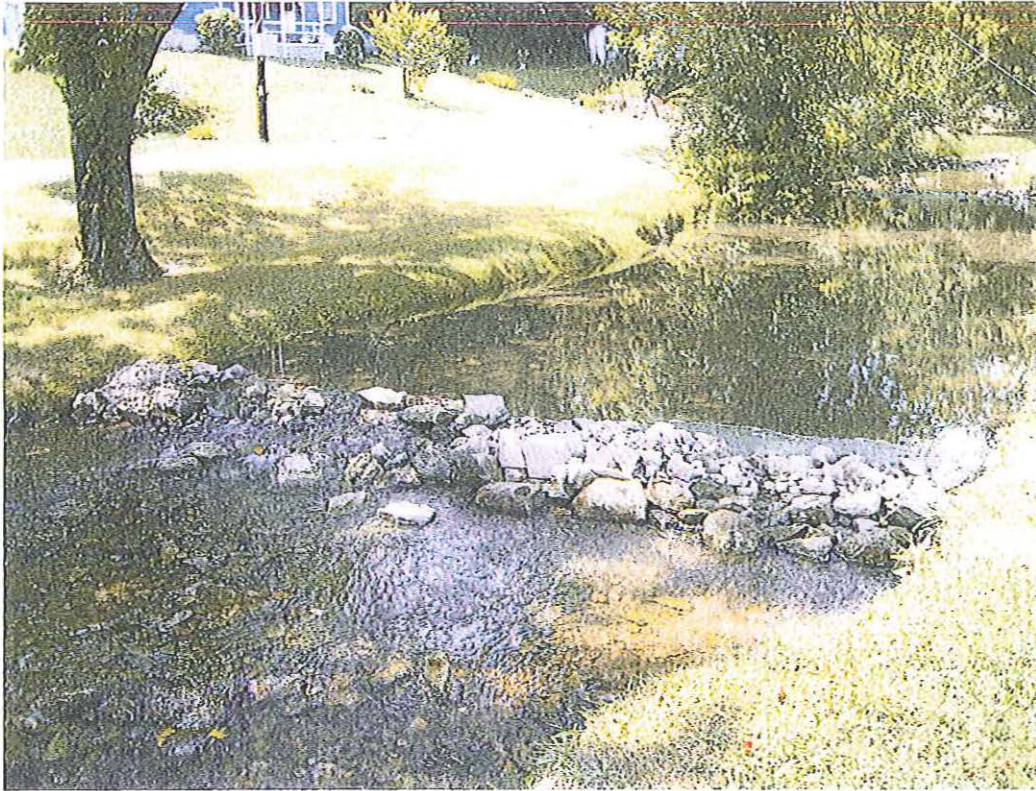
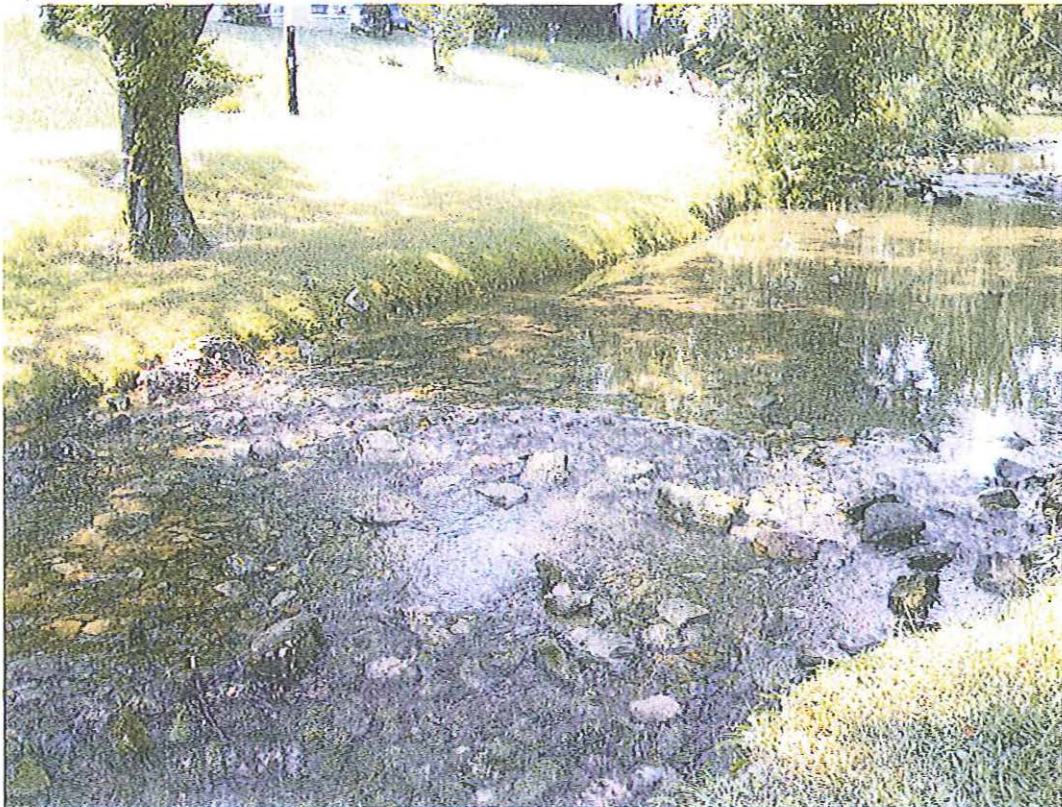
**Love Creek 06**

This weir was found and removed by Kirk Forgety on June 13, 2011.

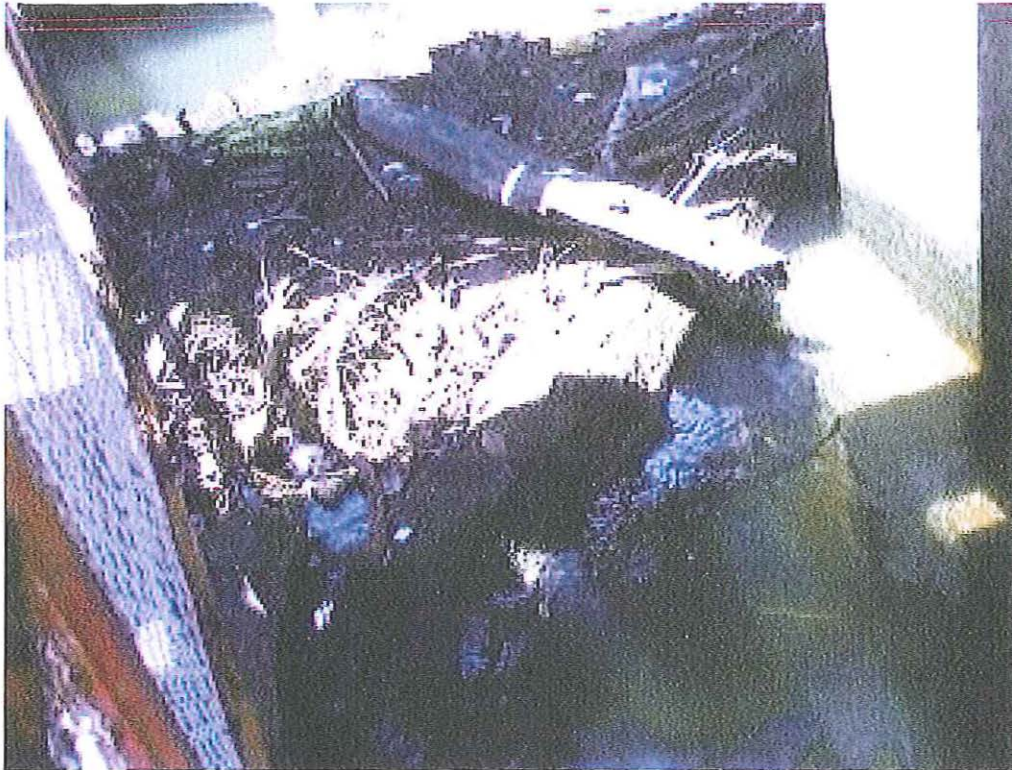
**Second Creek 01**

This Weir blocking Second creek at the mouth was removed on June 23, 2011, by Kirk Forgety and Josh Haston, an intern. Trash and logs were removed using ropes, hooks and a boat.

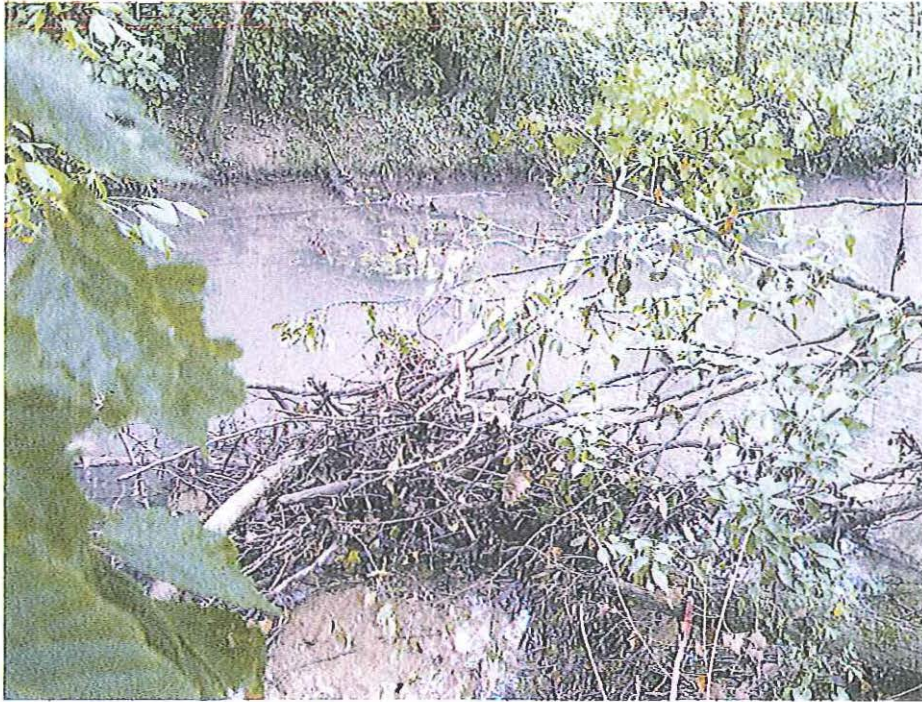
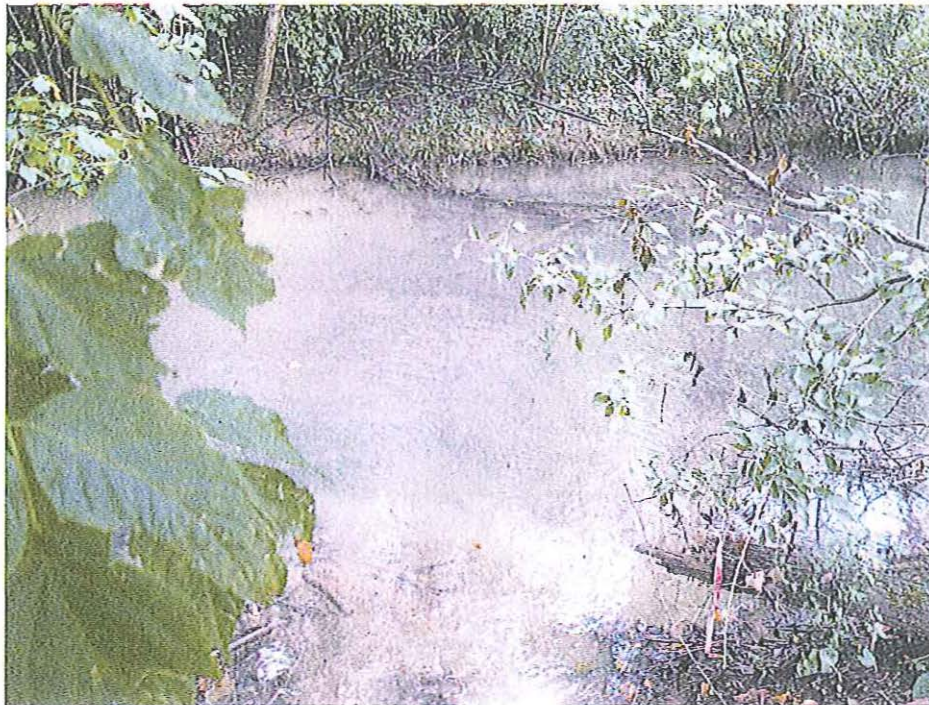
Ten Mile Creek 01

This weir was found and removed by Kirk Forgety on June 6, 2011. Approximately one-half of the stream was blocked by brush. It was removed to the shore.

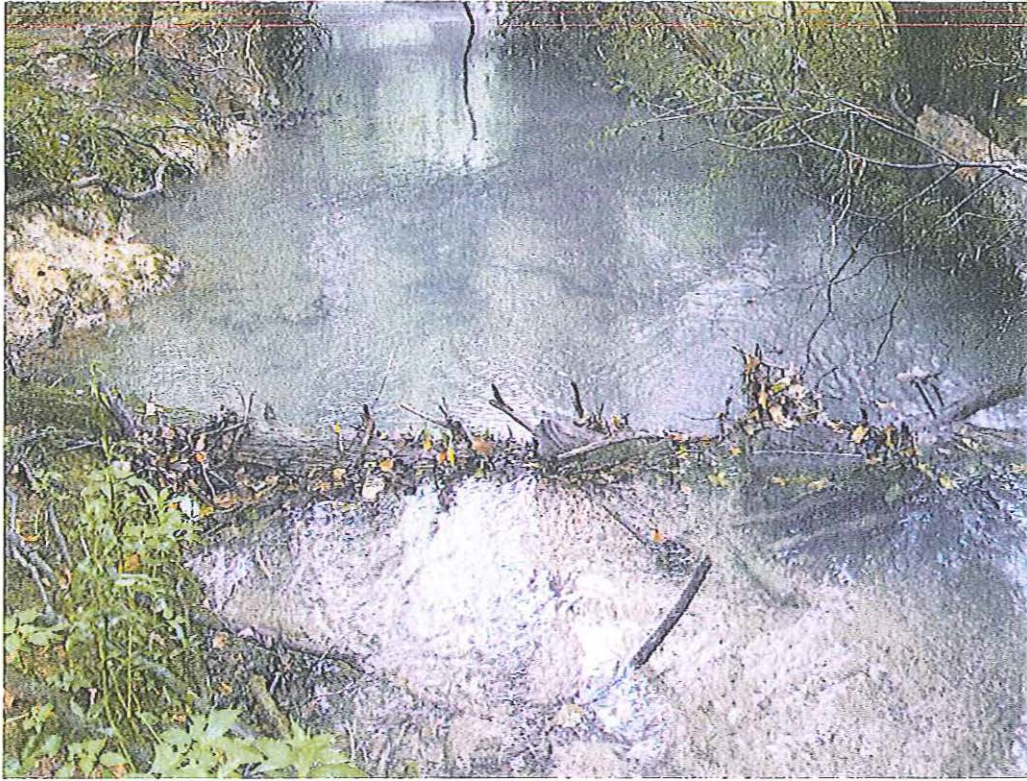
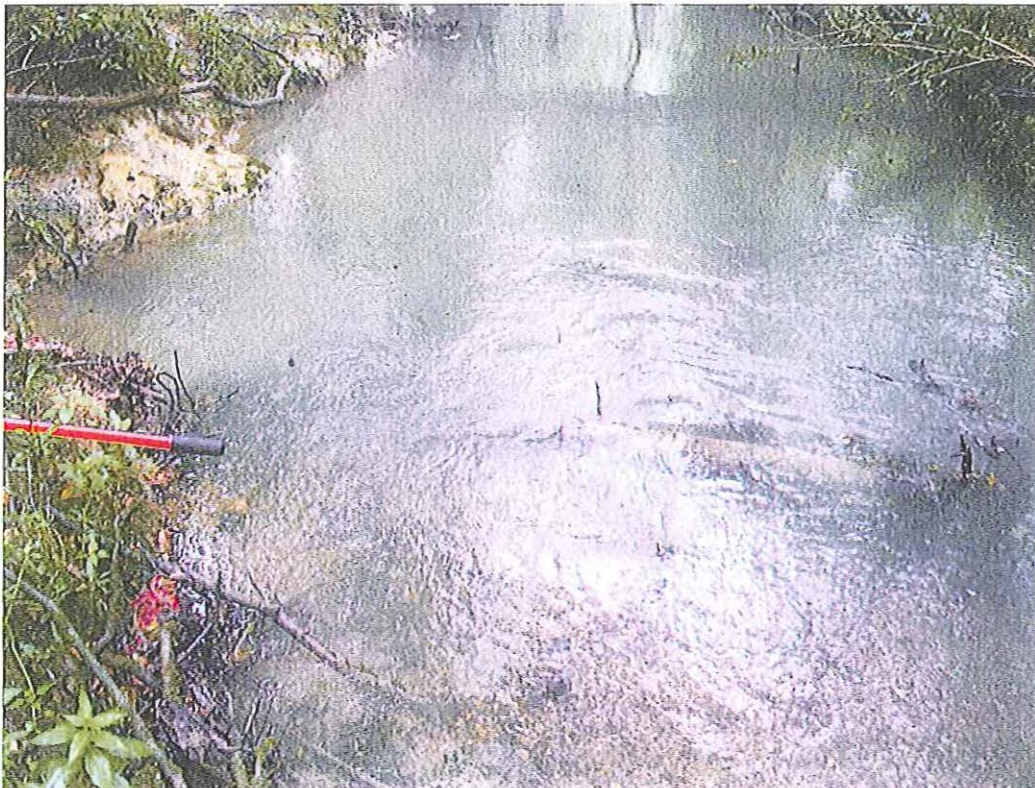
Ten Mile Creek 02

A fallen tree was trapping debris and blocking the stream. The tree was removed and the stream cleared by Kirk Forgety on June 6, 2011.

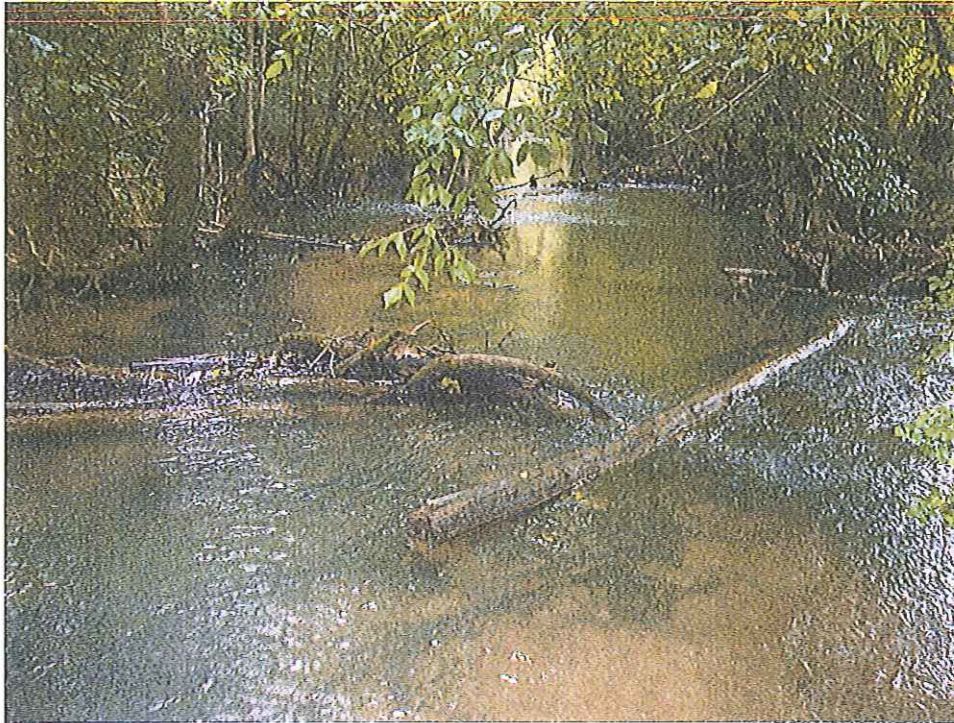
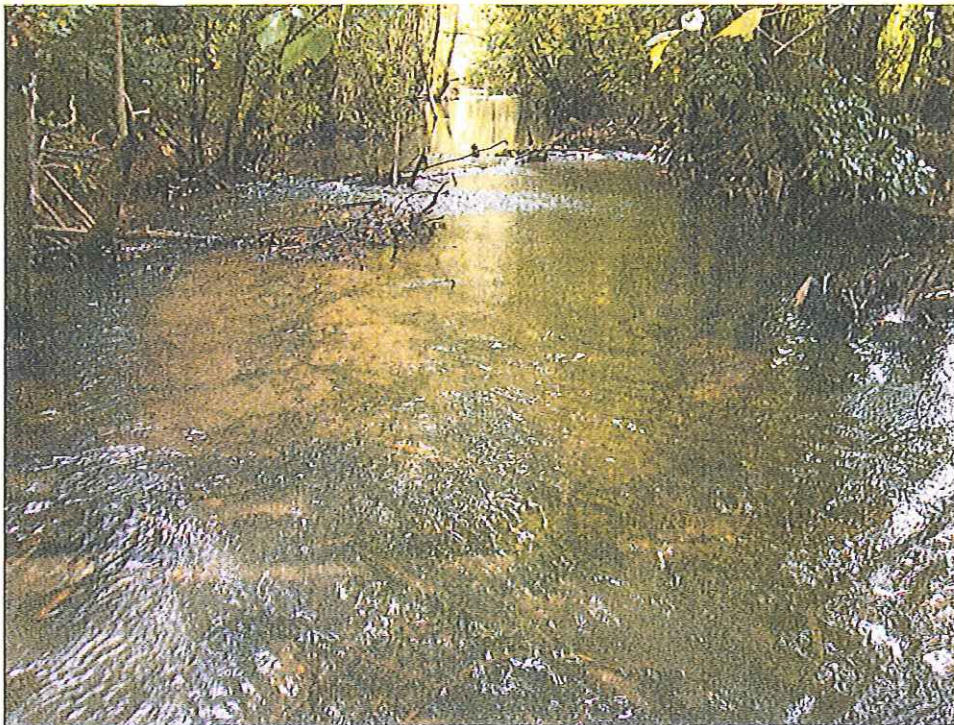
Ten Mile Creek 03

This weir was removed by Kirk Forgety and Jake Hudson from Ten Mile Creek beside the Greenway, on August 6, 2010. The weir consisted of logs across the creek with some debris caught behind it. The logs were removed.

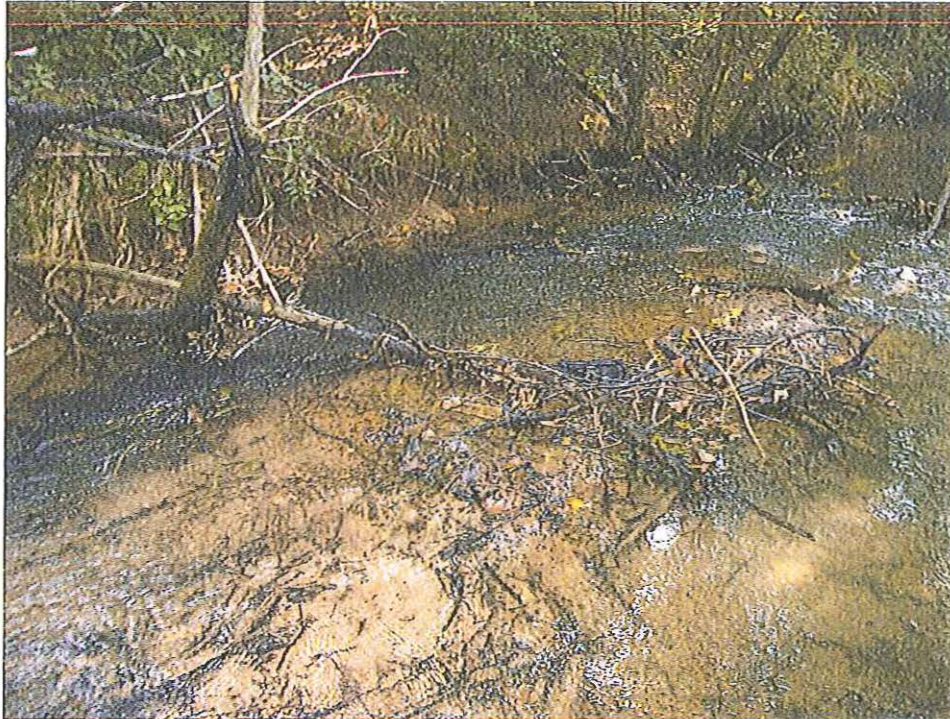
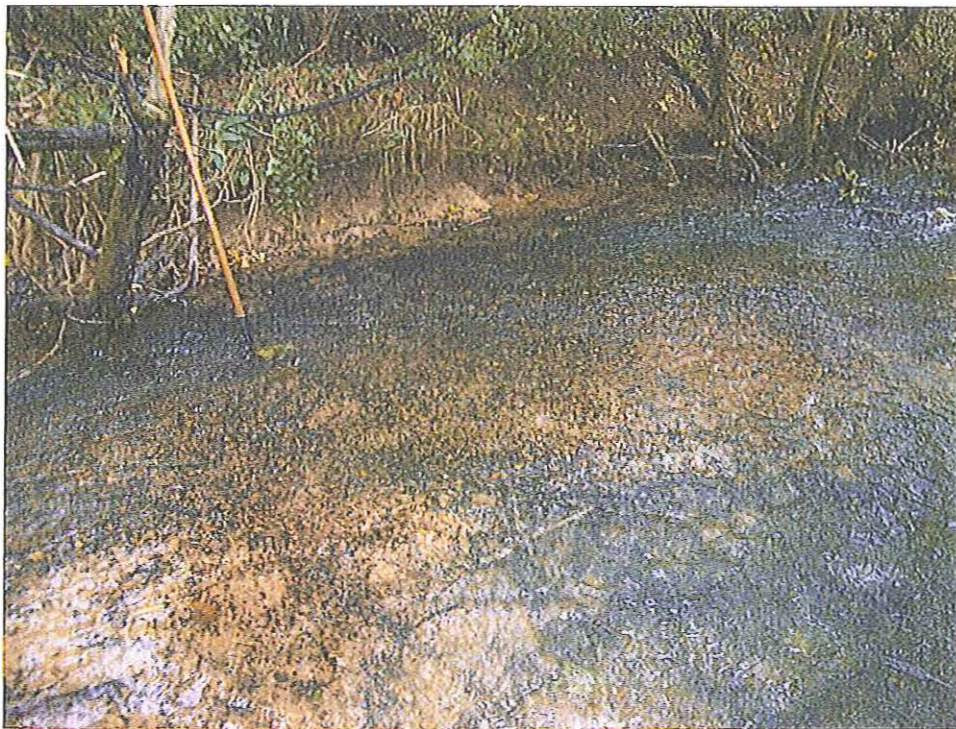
## Ten Mile Creek 04

This weir was removed by Kirk Forgety and Jake Hudson from Ten Mile Creek beside the Greenway, on August 6, 2010. The weir consisted of logs across the creek with some debris caught behind it. The logs and debris were removed.

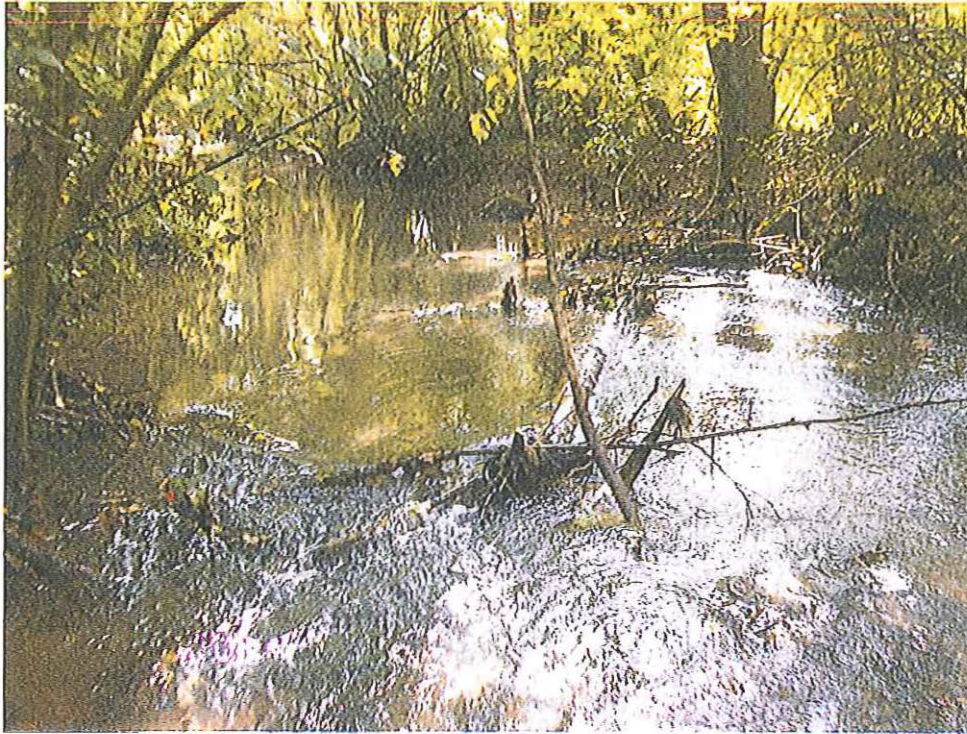
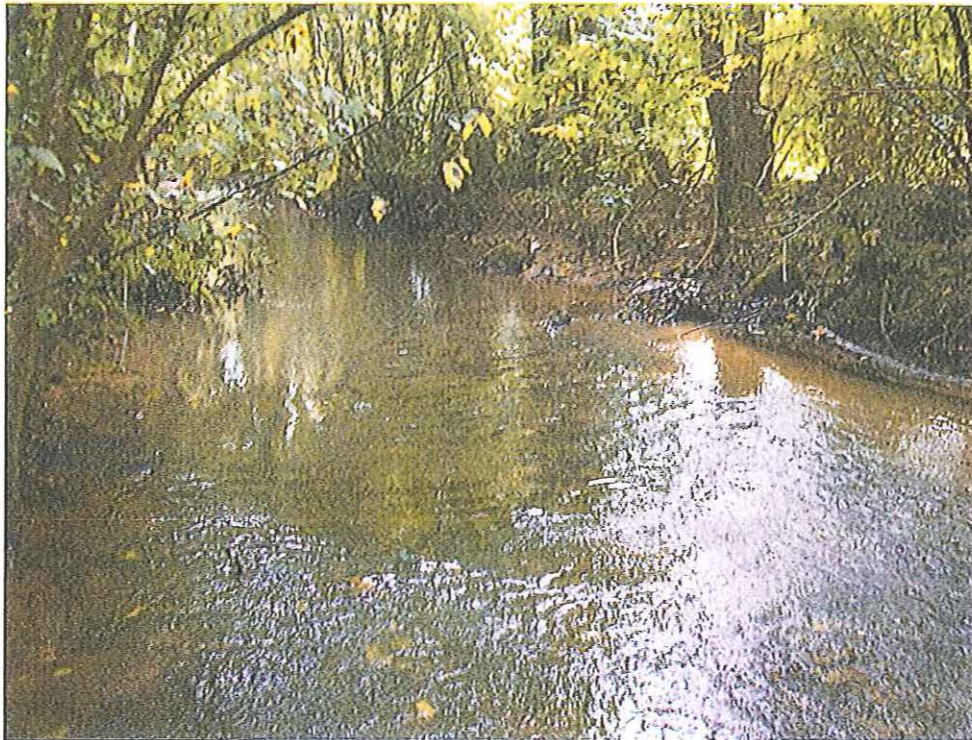
## Ten Mile Creek 05

This weir was removed by Kirk Forgety and Jake Hudson from Ten Mile Creek beside the Greenway, on August 6, 2010. The weir consisted of logs across the creek with some debris caught behind it. The logs and debris were removed.

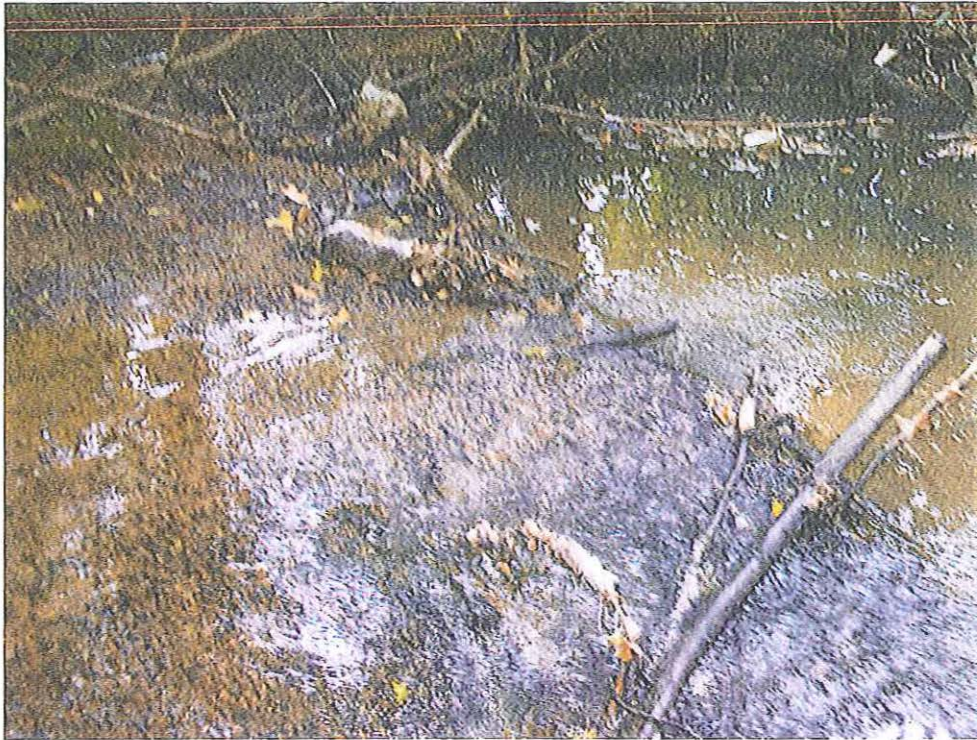
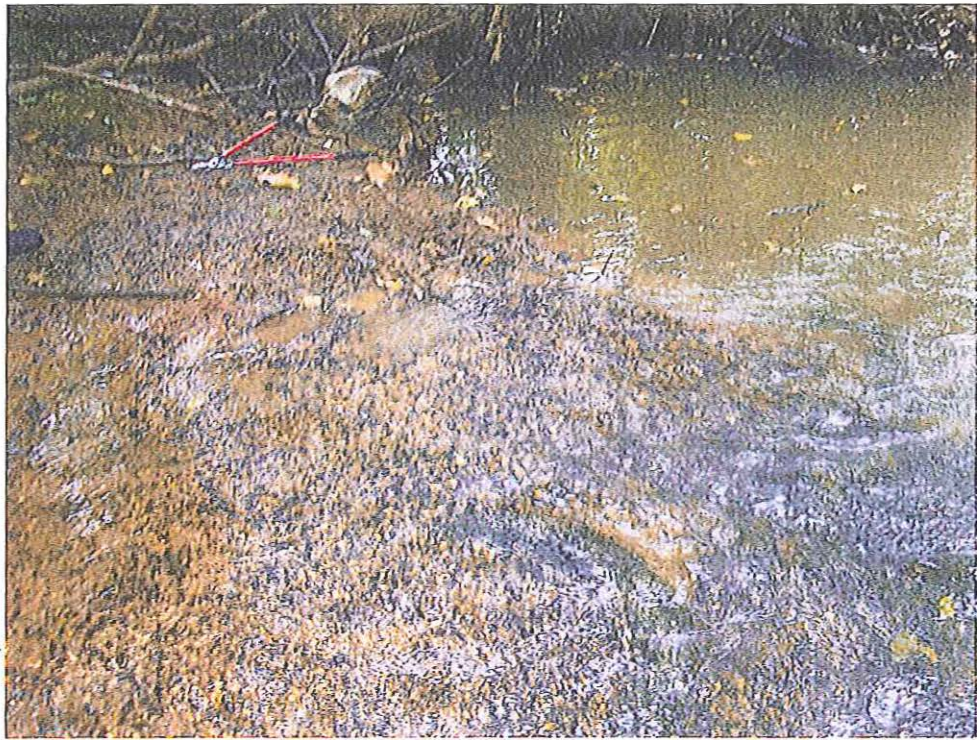
Ten Mile Creek 06

This weir was removed by Kirk Forgety and Jake Hudson from Ten Mile Creek beside the Greenway, on August 6, 2010. The weir consisted of logs across the creek with some debris caught behind it. The logs and debris were removed.
