# THE CITY OF KNOXVILLE TENNESSEE

## NPDES Permit Annual Report

National Pollutant Discharge Elimination System  
Stormwater Discharge Permit TNS068055  
July 1, 2010 - June 30, 2011

**RE: City of Knoxville, NPDES MS4 Permit # TNS068055  
2010 – 2011 Annual Report**

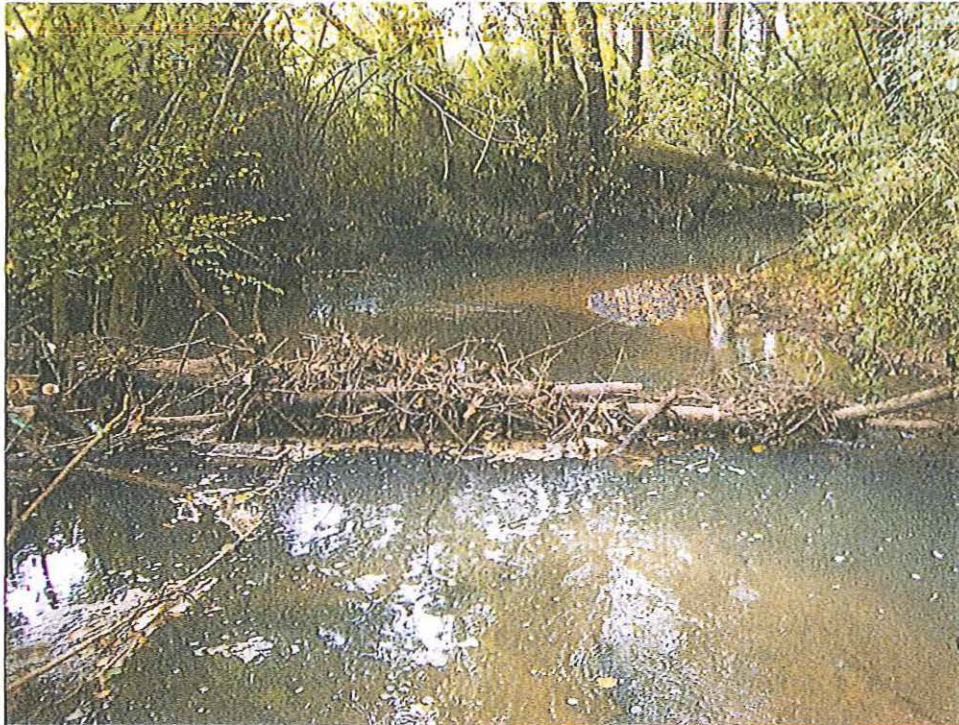
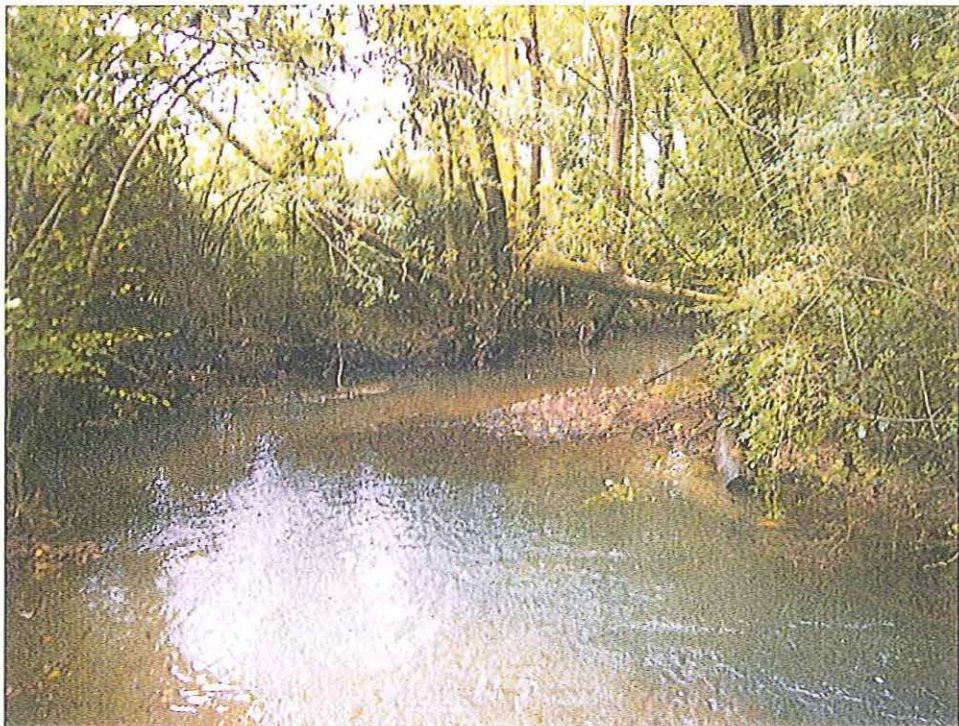
**Ten Mile Creek 07**

This weir was removed by Kirk Forgety and Jake Hudson from Ten Mile Creek beside the Greenway, on August 6, 2010. The weir consisted of logs across the creek with some debris caught behind it. The logs and debris were removed.

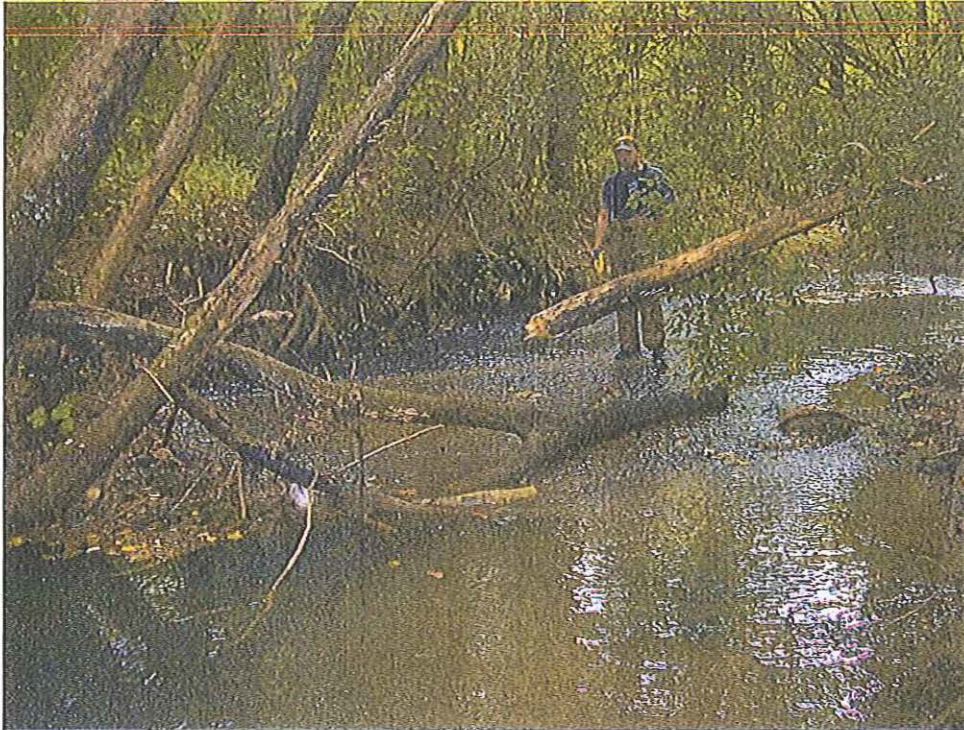
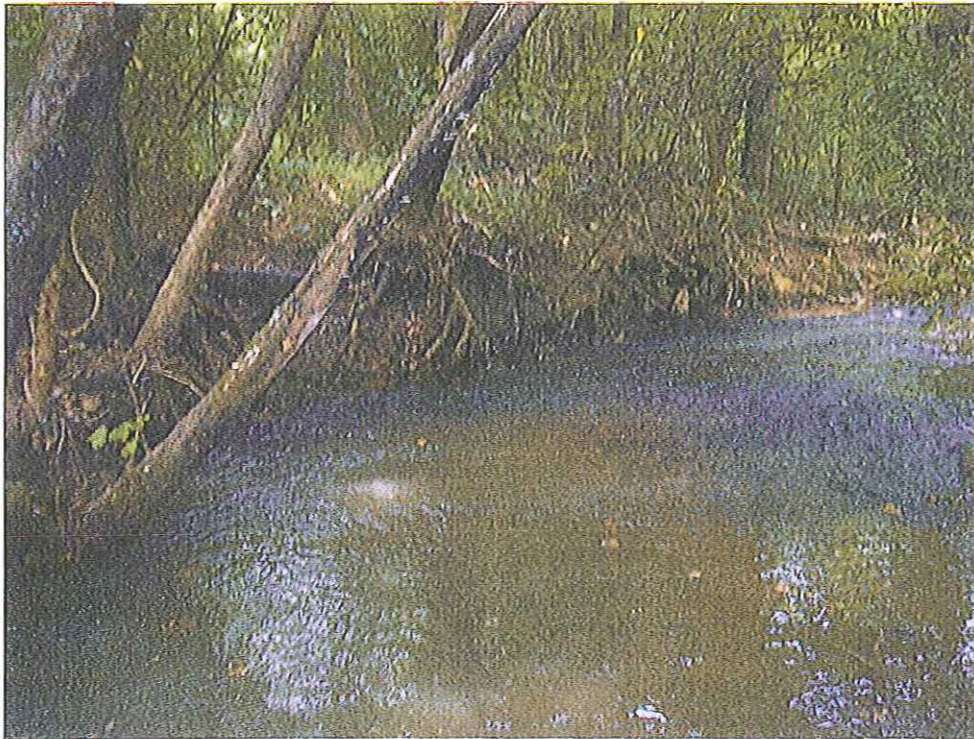
Ten Mile Creek 08

This weir was removed by Kirk Forgety and Jake Hudson from Ten Mile Creek beside the Greenway, on August 6, 2010. The weir consisted of logs across the creek with some debris caught behind it. The logs and debris were removed.

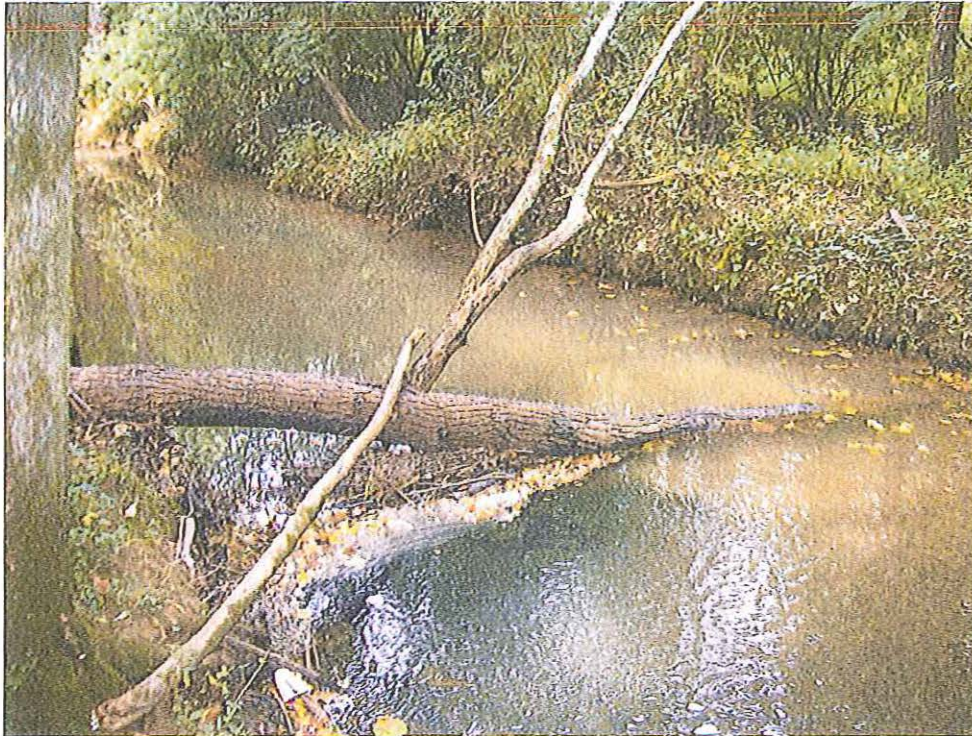
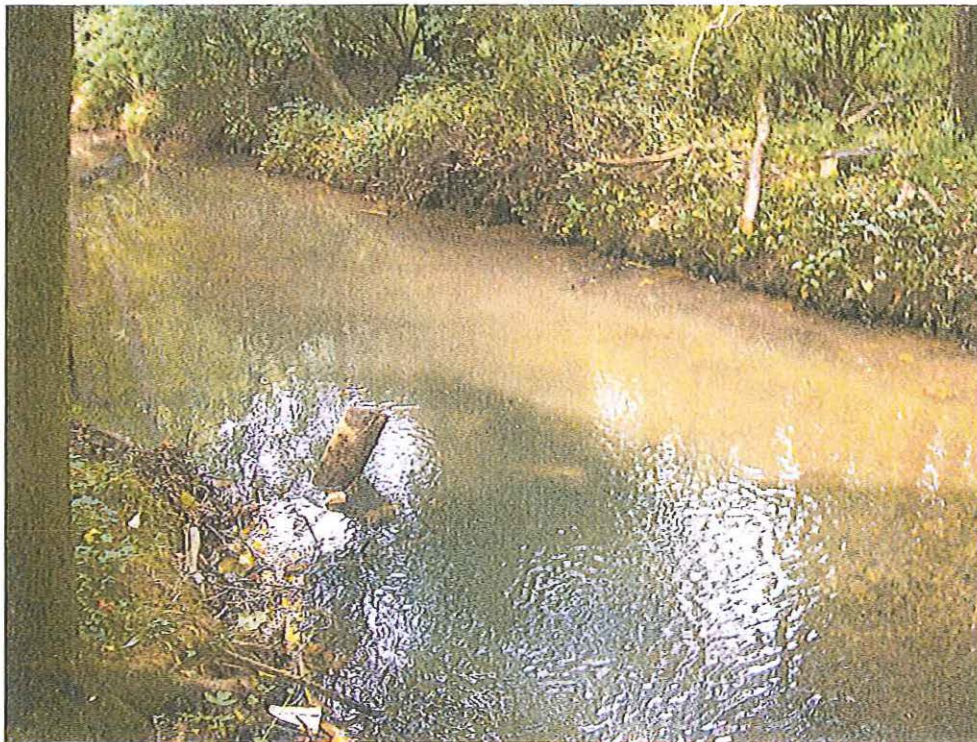
## Ten Mile Creek 09

This weir was removed by Kirk Forgety and Jake Hudson from Ten Mile Creek beside the Greenway, on August 6, 2010. The weir consisted of logs across the creek with some debris caught behind it. The logs and debris were removed.

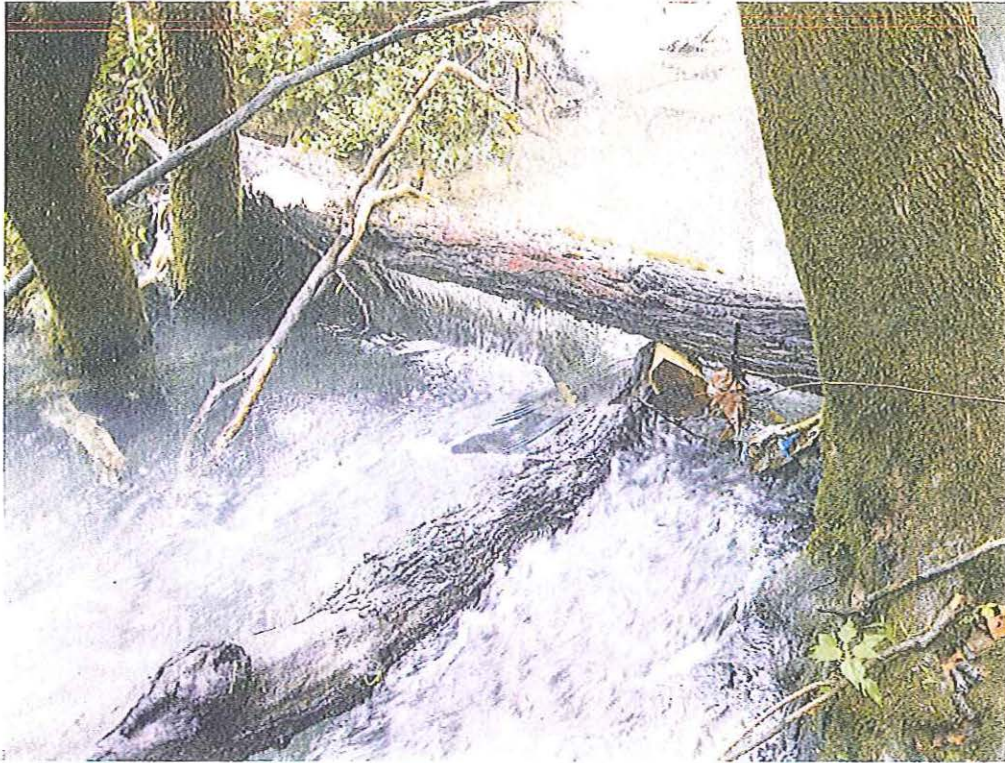
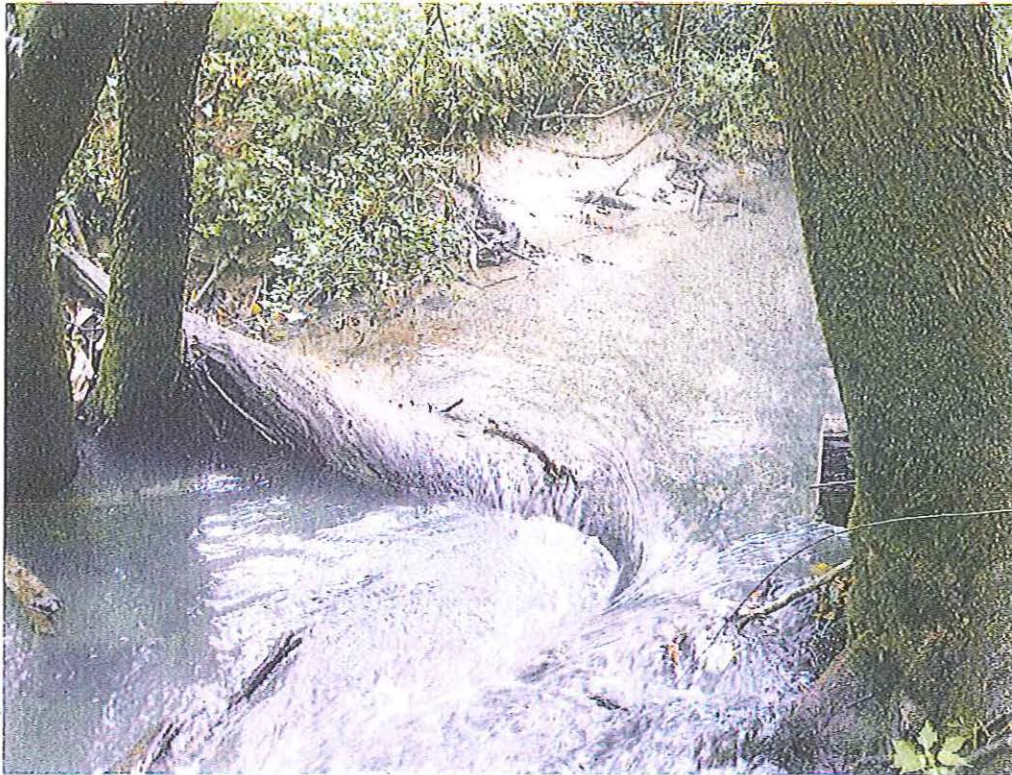
## Ten Mile Creek 10

This weir was found and removed by Kirk Forgety on June 6, 2011. The top horizontal tree and the vertical tree were removed, however the bottom horizontal tree was submerged and the root ball prevented its removal. The flow was restored.
